HISTORIC STRUCTURES REPORT
for
GRAND HAVEN SOUTH PIER
ENTRANCE AND INNER LIGHTS
Grand Haven (Ottawa County), Michigan

FINAL REPORT
September 8, 2015

Documentation of the existing conditions at the Grand Haven South Pier Entrance and Inner Lights was performed by Mr. Ken Czapski, AIA, a registered architect in Michigan, during a site visit on April 19 – 22, 2013. This section includes a general assessment of the pier, elevated catwalk and the entrance and inner light structures.

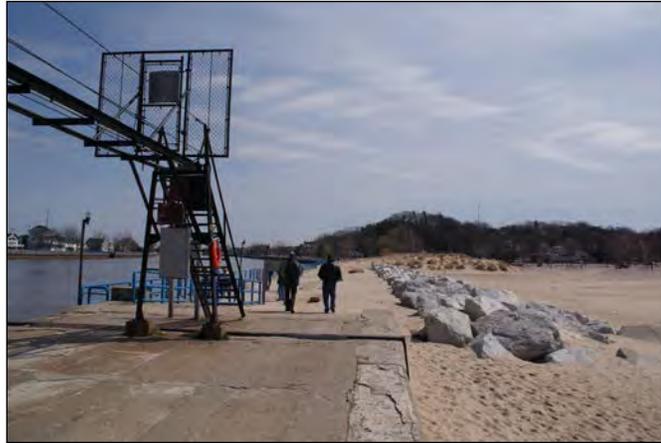
Photo III-A-17

Public access to the pier is unrestricted and it is an extremely popular destination for fishermen, tourists, bicyclists, park visitors and sightseers. An unprotected pier extending into the lake is often a dangerous place and signage at the terminus of the pier states that the pier “is not designed for public access” and that dangers and hazards are present as seen in Photos III-A-14, III-A-15 and III-A-16. The metal railing along the public walkway along the river’s edge abruptly ends at the small ramp at the beginning of the pier leaving the pier surface unprotected from the water’s edge. Refer to Photo III-A-17.

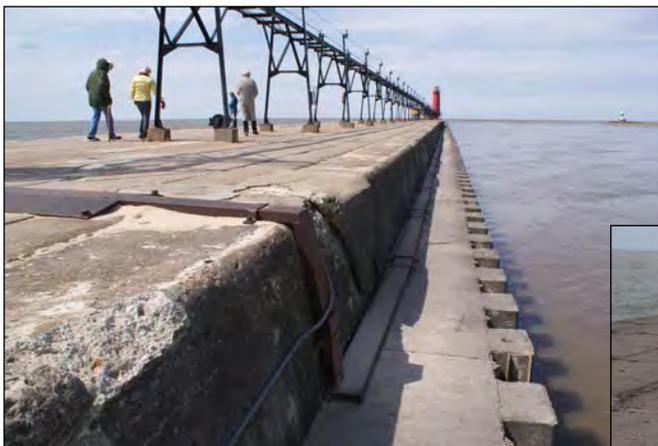
Photo III-A-18

The traffic surface of the pier is concrete which is in fair condition, however, there are many areas of deterioration and many potential tripping hazards as seen in Photos III-A-18, III-A-19 and III-A-20. The elevation of the walking surfaces changes a number of times along its length and width with steps and sloped ramp surfaces providing the transition between levels. Refer to Photos III-A-21 and III-A-22. Although there are areas of concern, the pier in general, provides a barrier free accessible, albeit somewhat dangerous, walkway from the State Park parking lot to the Entrance and Inner Light structures.

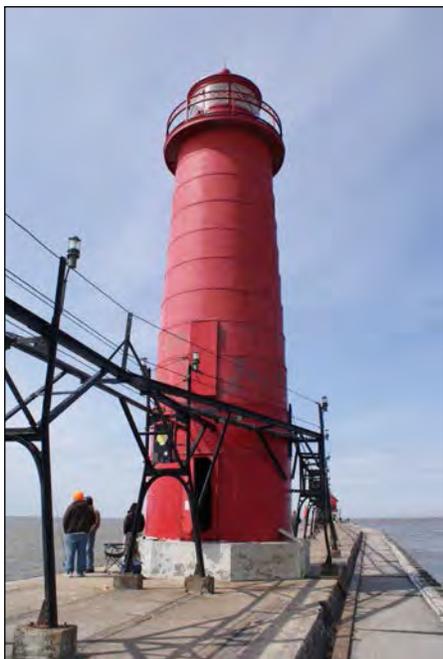
Photo III-A-23

The Inner Light, placed approximately halfway along the length of the pier, is situated upon an eight sided concrete base, Photo III-A-23, that is 2'-8" above the main pier deck surface. Access around the structure's base is maintained at the main pier deck surface as seen in Photo III-A-24. At the Entrance Light, located at the far western end, there is a 1'-1" step up from the main pier deck surface to the walkway at the entry to the structure, as seen in Photo III-A-25. Further discussion of these areas are found in the respective sections describing the existing conditions of the Entrance and Inner Lights.

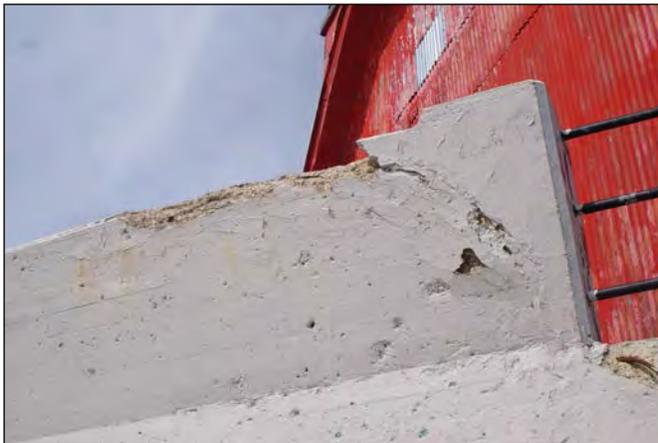
Photo III-B-5

Exterior concrete surfaces are, in general, in fair condition although there are many areas where severe spalling has occurred which has exposed the reinforcing steel. Refer to Photos III-B-5 and III-B-6. Additional information is found in the Exterior Conditions and Analysis section.

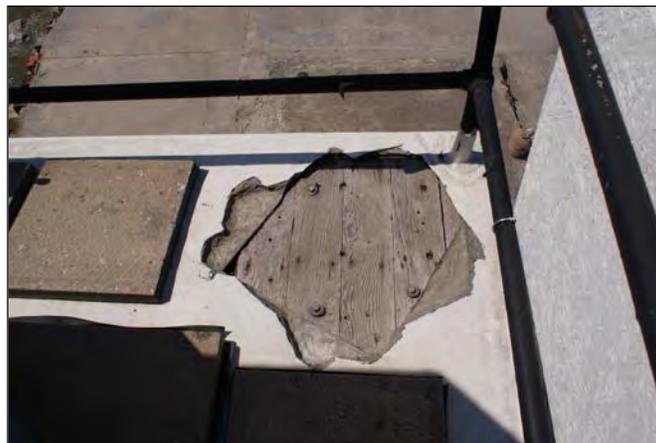
Photo III-B-15

Finish material in the Lantern Room was not removed as part of this investigation and the wood frame structure could not be seen. The lantern deck has been covered with a PVC single-ply membrane that has a very large section missing at the northwest corner, as seen in Photo III-B-15, exposing the wood deck and creating a major point of entry for water into the structure. The wood decking appeared sound, however, this situation warrants immediate repair.

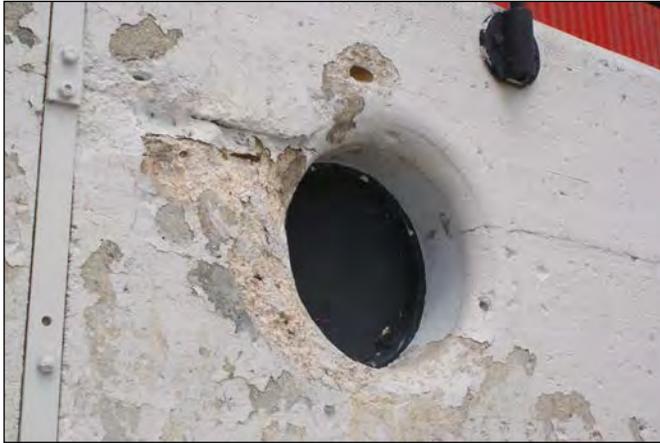
Photo III-B-20

The vertical poured concrete walls of the Entrance Light are in fair condition with some areas of spalling as seen in Photos III-B-20, III-B-21, III-B-22 and III-B-23. A cast iron clean-out, Photo III-B-24, is cast into the south wall. This clean-out served the sanitary waste line in the main level of the building.

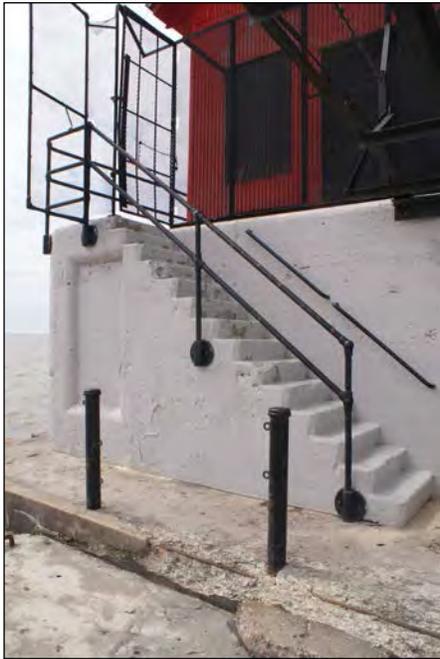
Photo III-B-25

A set of cast concrete steps is located at the southeast corner of the building and provides access to the upper level walkway as seen in Photo III-B-25. There is extensive deterioration of the concrete steps including cracking and spalling. Refer to Photos III-B-26 and III-B-27. A metal pipe handrail, which is in good condition, is anchored to the concrete wall and a 1 3/4" metal pipe handrail/guardrail is bracketed to the face of the exposed stairway wall. This handrail/guardrail is in poor condition. The base of the lowest support post, as seen in Photo III-B-28 has completely rusted and broken loose from the support bracket. Severe rusting has also occurred at other post bases and brackets.

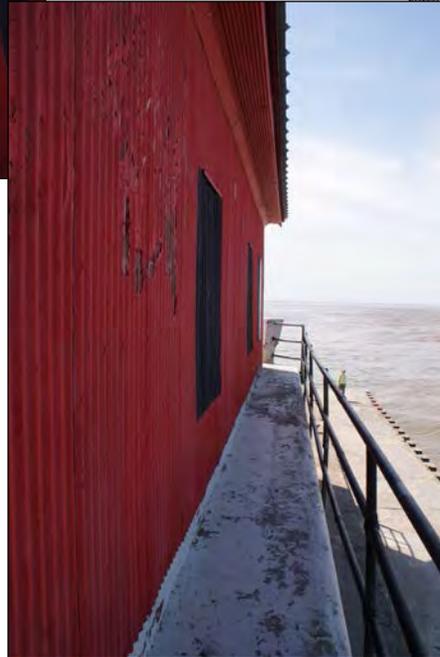
Photo III-B-31

The upper level walkway which is also the roof of the main level, is 2' – 2" wide on the north side, Photo III-B-31; and south side, Photo III-B-32 and 4' – 0" wide on the east side, Photo III-B-33. Spalled concrete edges present a safety hazard as seen in Photo III-B-34. The narrow walkway transitions to a larger deck at the west end "bow". Refer to Photos III-B-35 and III-B-36. Poured concrete walls form the guardrail along this area. The paint on these walkway surfaces, which is also the roof surface for the lower level, is in poor condition and there is some minor cracking. A metal coal room hatch, as seen in Photos III-B-37 and from the interior in Photo III-B-38, is located on this deck. The metal hatch cover and frame are rusted and the paint is in poor condition.

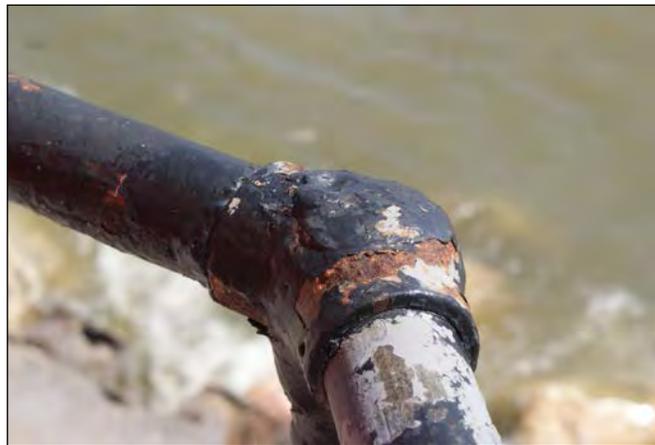
Photo III-B-43

A 3' – 6" metal pipe guardrail with three horizontal rails extends around this upper level walkway. The guardrail is constructed of 1 3/4" diameter metal pipe as seen in Photos III-B-39 and III-B-40. Similar to the railing at the stair, the guardrail posts are bracketed to the face of the concrete wall surface. Refer to Photos III-B-41 and III-B-42. Three of the guardrail pipe posts have been replaced with 2 x 2 steel angle. Many of the metal pipe guardrail components are in poor condition with members bent and rusted. The paint finish, Photo III-B-43, is in poor condition.

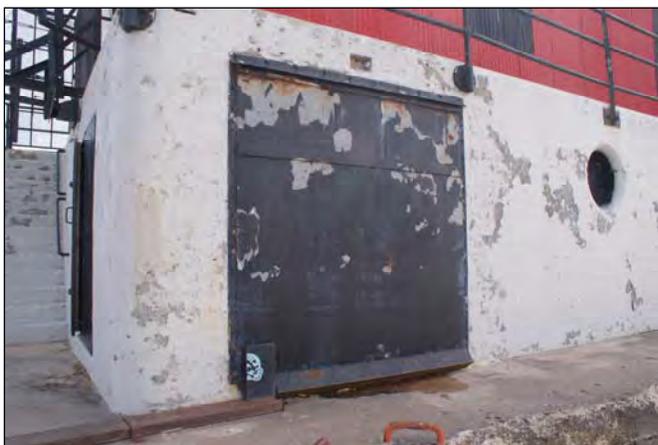
Photo III-B-69

Adjacent to the watertight door is a large door measuring 6' – 8" wide x 6' – 11 ½" high that served as the door into the boat room, as seen in Photo III-B-69. Original drawings indicate doors with half glass lights, however, these doors have been removed and replaced with steel plates. Additional bracing has been installed and welded to the steel plate as seen in Photo III-B-70. The door and frame are in poor condition with extensive rust and deterioration. A large floor drain, Photo III-B-71, is found inside this door and is in similar poor condition. The paint finish on all door, frame and grating components is very poor.

A hand operated derrick, as detailed in historic drawing # RHL1018434, was located above this boat room door to facilitate the handling of boats and materials. Although this derrick is no longer extant, bolt locations for the original mounting brackets above the doors are still visible as seen in Photo III-B-69.

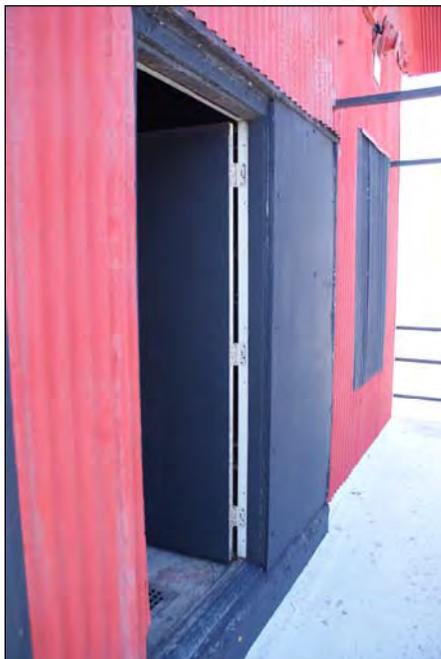
Photo III-B-72

On the upper level a single 3'-0" x 6'-8" hollow metal steel door is set in a 6'-0" x 7'-0" framed door opening. This door, seen in Photos III-B-72 and III-B-73 is in poor condition and replaced a pair of doors with glass lights previously located in this opening.

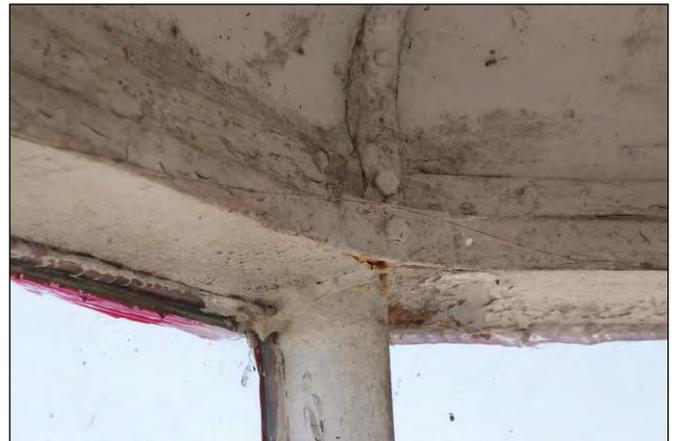
Photo III-B-130

Of the eight glazed openings in the Lantern three panels are glazed with Lexan material and two of the remaining five glass panels are broken. The glazed openings measure 2'-4 1/2" wide x 3'-0 1/2" high. The exposed metal sill and vertical mullions of the lantern are in good condition, however, the paint is in poor condition. There is considerable moss growth along the metal sill, as seen in Photo III-B-127. The lantern ceiling is exposed light gage metal with a paint finish. All metalwork is in sound condition, however, the paint finish on all surfaces is in poor condition. Refer to Photos III-B-128, III-B-129 and III-B-130.

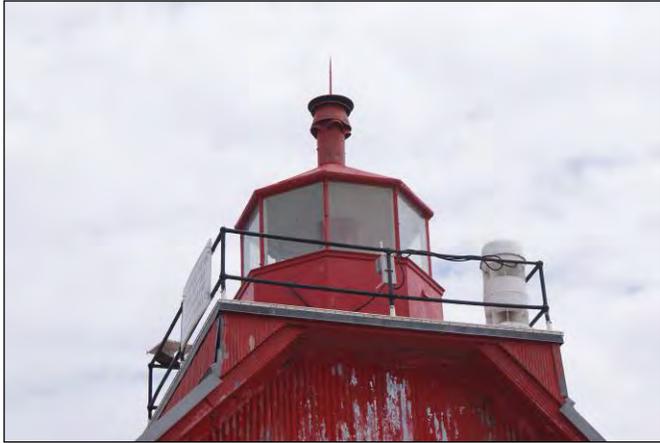
Photo III-B-135

The exterior of the lantern is shown in Photos III-B-135 and III-B-136. Exterior walls of the lantern are flush metal with a paint finish. Vents are simple capped openings, as seen in Photo III-B-137. Minor areas of damage including rust are found in various locations, as seen in Photos III-B-138, III-B-139 and III-B-140. The lantern roof is flat metal panels terminating at a simple fascia without gutters. All exterior metal on the lantern is in good condition. The paint finish is in average condition. At the peak of the lantern is a ventilator that was apparently installed as part of the 1922 renovation. It is identified as a “new ‘Kernchen’ ventilator” on these drawings and is shown in Photo III-B-141.

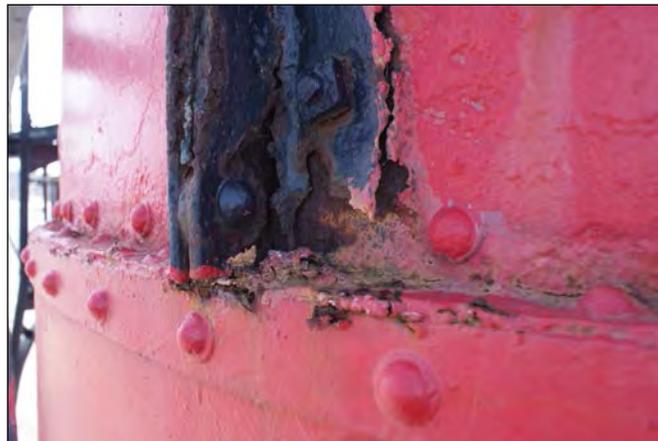
Photo III-C-2

The cylindrical tower is constructed of cylindrical metal rings and angles. The bottom section of the tower base is 12'-6" outside diameter and steps down in 3" increments to 10'-0" outside diameter at the top section below the lantern deck. These metal sections form the walls and the structure of the tower. Original 1902 drawings indicate plate thicknesses of 3/8" at the lower three sections of the tower, and incrementally stepping down to 5/16", 1/4" and 3/16" in plate thickness. Riveted metal angle seats form the bearing points between the cylindrical sections. These horizontal ledges tend to trap water causing rust and scale to form, as seen in Photo III-C-2.

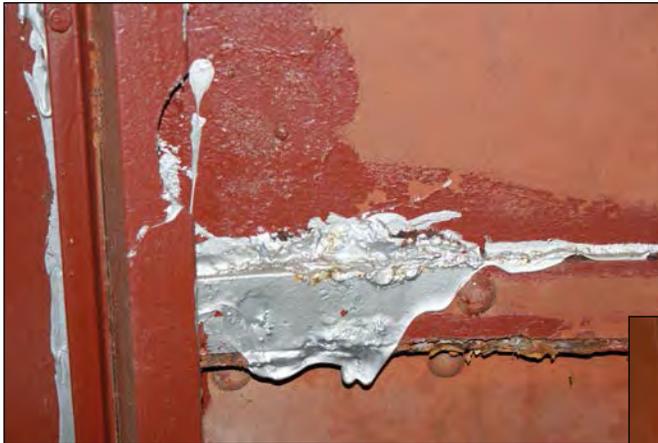
Photo III-C-3

Interior views of these horizontal joints are shown in Photos III-C-3 and III-C-4 which show rust sealant material, and coatings of rust inhibitive primer. Internally there are a number of struts, bracing and other metal framework that reinforce the structure and provide framing for the floors. Photos III-C-5 and III-C-6 show some of the internal framework, which is in relatively good condition.

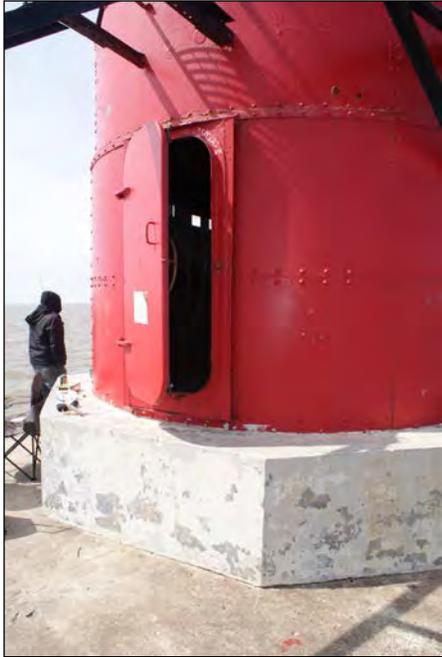
Photo III-C-27

The Inner Light tower is entered through a 2'-2" x 5'-6" gasketed, water-tight steel door, as seen in Photos III-C-27, III-C-28 and III-C-29. This style of door also has a continuation of the frame at the bottom of the opening, requiring extra caution when stepping through. This condition is seen in Photo III-C-30. The door hardware consists of a pull handle and padlock hasp on the exterior and a multi-point lock mechanism on the interior. All door components are in good condition and operating order. Paint finish is in poor condition. The original 1922 drawings indicate a solid steel plate door. The water-tight door was installed in the 1990s.

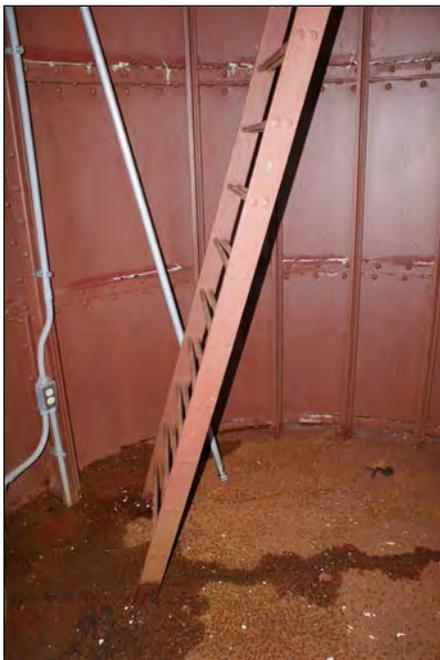
Photo III-C-67

A fixed steel ladder with double rungs provides access to the lantern. Refer to Photo III-C-67. A 1'-11" x 2'-5" floor opening in the lantern floor is seen in Photos III-C-68 and III-C-69. Two damaged hinges, Photo III-C-70, are found along the edge of the opening and the steel plate hatch cover is removed and laid against the lantern wall as seen in Photo III-C-71. The ceiling of the third level, or the underside of the lantern deck floor, is cement plaster which is in poor condition. Photo III-C-72 shows the loose and missing plaster. The paint finish is in poor condition.
