HISTORIC STRUCTURES REPORT
for
GRAND HAVEN SOUTH PIER
ENTRANCE AND INNER LIGHTS
Grand Haven (Ottawa County), Michigan

FINAL REPORT
September 8, 2015

Documentation of the existing conditions at the Grand Haven South Pier Entrance and Inner Lights was performed by Mr. Ken Czapski, AIA, a registered architect in Michigan, during a site visit on April 19 – 22, 2013. This section includes a general assessment of the pier, elevated catwalk and the entrance and inner light structures.

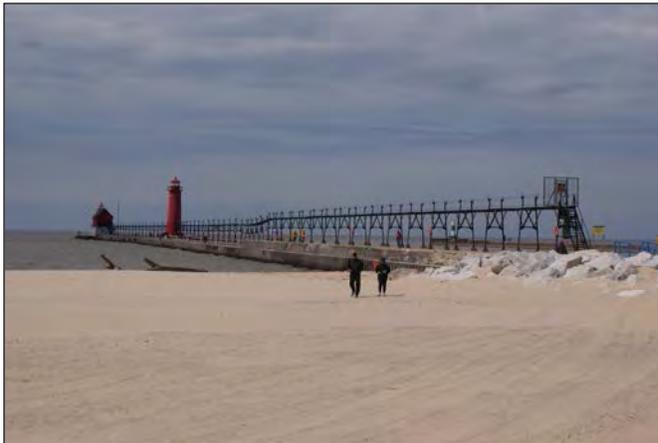
Photo III-A-1

The Grand Haven Entrance and Inner Lights, as seen in Photo III-A-1, are located on a pier constructed on the south side of the mouth of the Grand River where it flows into Lake Michigan on Michigan’s west coast. Known as the South Pier, this structure, along with the pier on the north side of the river mouth, is owned and maintained by the U. S. Army Corps of Engineers. The North Pier, which has a navigational light at the west end is shown in Photo III-A-2. The inclusion of the South Pier in this report is for informational purposes only as it is the “site” and approach to both lights; an in depth analysis of the pier is not included.

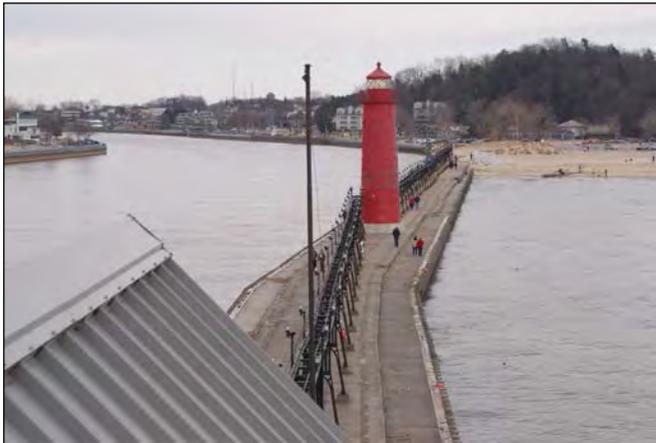
The South Pier extends approximately 1,515 feet from the sand beach shoreline on the south face of the pier, which marks the beginning of the Grand Haven State Park, a popular 48 acre park, as seen in Photo III-A-3 and terminates at the Outer Light structure, as seen in Photo III-A-4. The pier, which was built in segments, began with the construction of a series of shoreline revetments in 1857 – 1858 along the south bank of the Grand River. Construction of the present day 1,515 foot long pier progressed as follows:

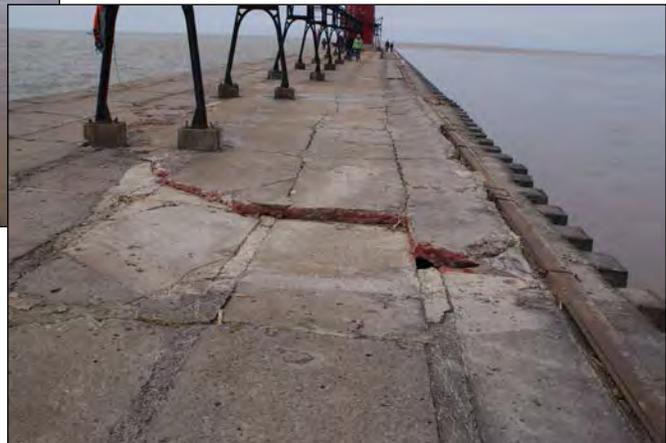
Photo III-A-19

The traffic surface of the pier is concrete which is in fair condition, however, there are many areas of deterioration and many potential tripping hazards as seen in Photos III-A-18, III-A-19 and III-A-20. The elevation of the walking surfaces changes a number of times along its length and width with steps and sloped ramp surfaces providing the transition between levels. Refer to Photos III-A-21 and III-A-22. Although there are areas of concern, the pier in general, provides a barrier free accessible, albeit somewhat dangerous, walkway from the State Park parking lot to the Entrance and Inner Light structures.

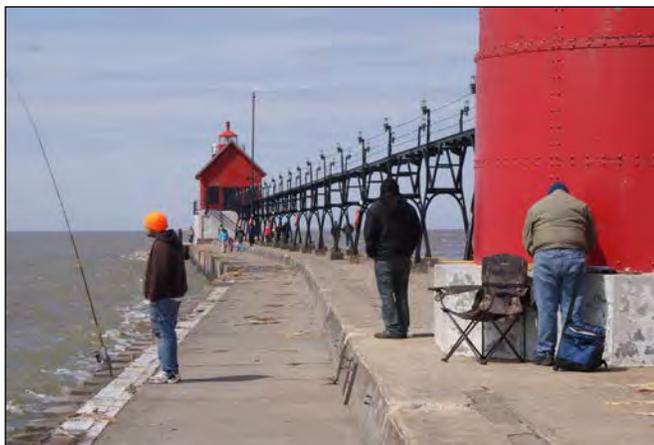
Photo III-A-24

The Inner Light, placed approximately halfway along the length of the pier, is situated upon an eight sided concrete base, Photo III-A-23, that is 2'-8" above the main pier deck surface. Access around the structure's base is maintained at the main pier deck surface as seen in Photo III-A-24. At the Entrance Light, located at the far western end, there is a 1'-1" step up from the main pier deck surface to the walkway at the entry to the structure, as seen in Photo III-A-25. Further discussion of these areas are found in the respective sections describing the existing conditions of the Entrance and Inner Lights.

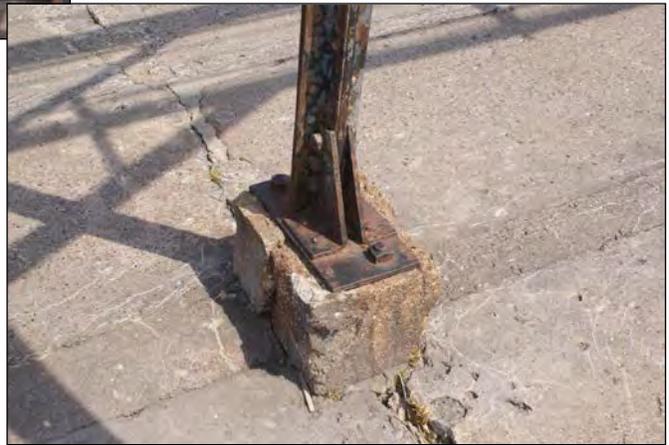
Photo III-A-33

The metal stanchions consist of angles that bear upon small raised concrete piers as seen in Photo III-A-33. There is localized damage at the lower portions of some of the stanchions including bent and damaged members and some rusting, as seen in Photos III-A-34 and III-A-35, along with some damaged and spalling concrete at the raised support piers. These areas appear to be minor and the overall integrity of the catwalk appears sound, however, further evaluation and monitoring is recommended. The walking deck surface of the catwalk was removed in 1988 for safety reasons and to raise funds by salvaging the wood planks for donors. Presently the catwalk serves only as a support structure for the lighting system, Photo III-A-36, electrical panels, Photo III-A-37 and some public safety equipment, Photo III-A-38.

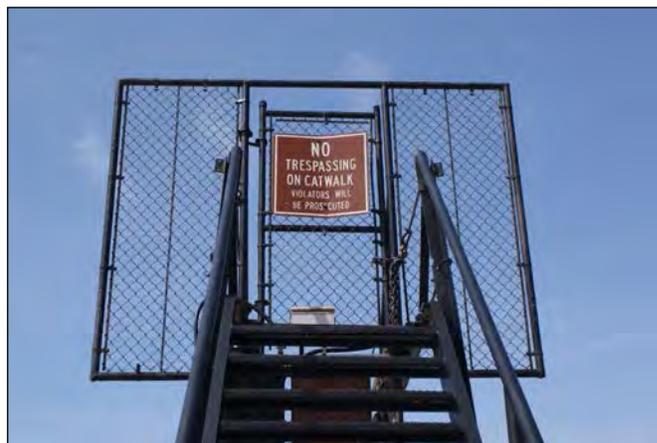
Photo III-A-39

The elevated catwalk is entered by a stairway at its eastern end as seen in previous Photo III-A-16. A security fence and gate, Photo III-A-39, along with signage is present to keep the public off the catwalk. It is now only accessed for lighting maintenance purposes by authorized city personnel.

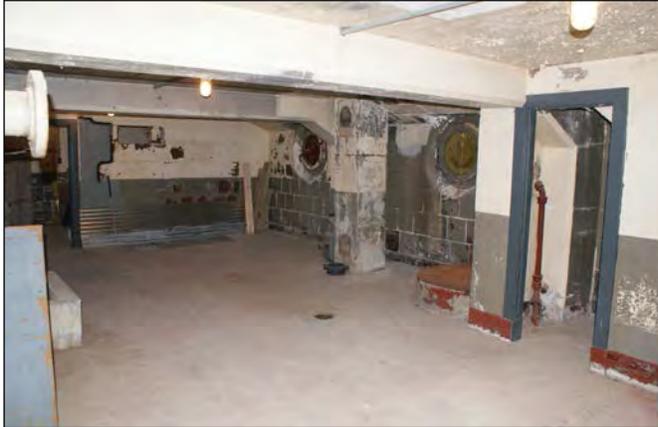
seen in Photo III-B-3 showing the concrete beams, columns and underside of the structural slab that forms the finished ceiling. One concrete beam near the entrance door is damaged and has a large vertical crack. Two supplementary wood columns, 3 ½" x 5 ½" in size, have been installed to provide support as seen in Photo III-B-4. The floor / ceiling slab, beams and columns otherwise are all in good condition with some minor areas of spalling on the interior.

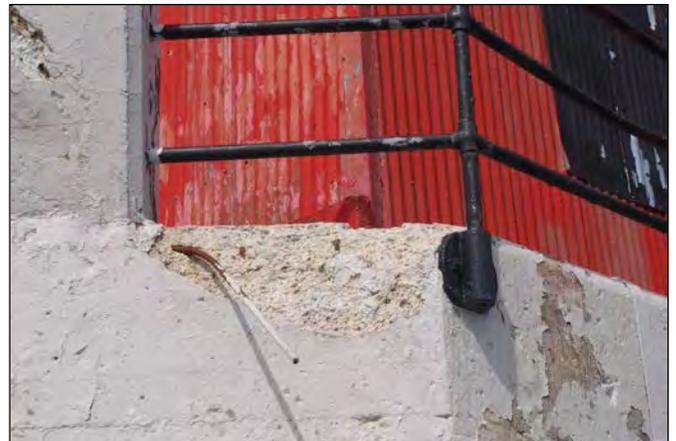
Photo III-B-6

Exterior concrete surfaces are, in general, in fair condition although there are many areas where severe spalling has occurred which has exposed the reinforcing steel. Refer to Photos III-B-5 and III-B-6. Additional information is found in the Exterior Conditions and Analysis section.

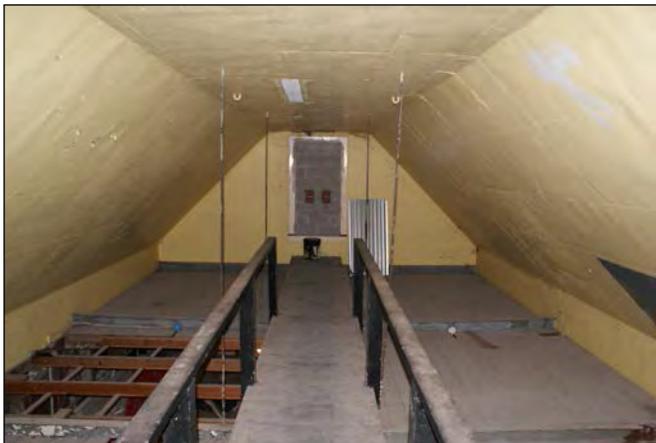
Photo III-B-13

From the upper floor level a steep wood stair provides access to a walkway that leads to the Service Room below the Lantern Room. This walkway runs the length of the building and once provided access from the elevated catwalk prior to 1922 into the building through a door at the gable end, Photo III-B-13, now closed off. Four $\frac{1}{2}$ " diameter steel rods support two 5" deep c-channels that span between outside walls and provide support for the walkway. Floor/ceiling rafters in this area are $1\frac{3}{4}$ " x $5\frac{7}{8}$ " wood rafters spaced 16" on center. Part of the floor is decked with random width $\frac{3}{4}$ " tongue and groove wood plank, part with plywood and part of the floor is open. All structural members appeared in reasonably good condition.

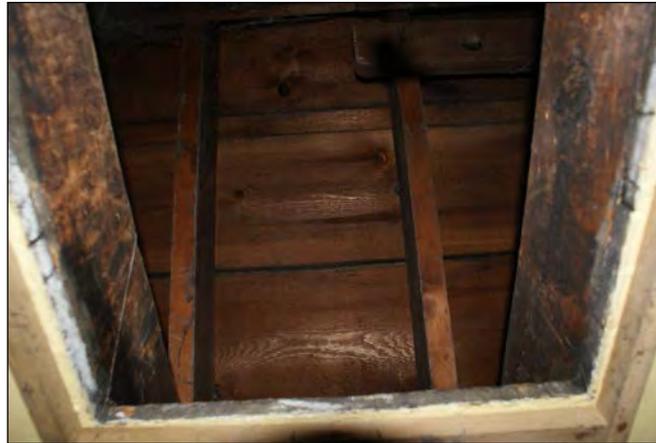
The building roof is wood framed with 1¾" x 5 7/8" wood rafters spaced 16" o.c. Roof sheathing is 1" thick random width planking. A partial view of the roof structure is shown in Photo III-B-14 looking up through the attic access hatch. Where observed, the roof framing appeared to be in sound condition.

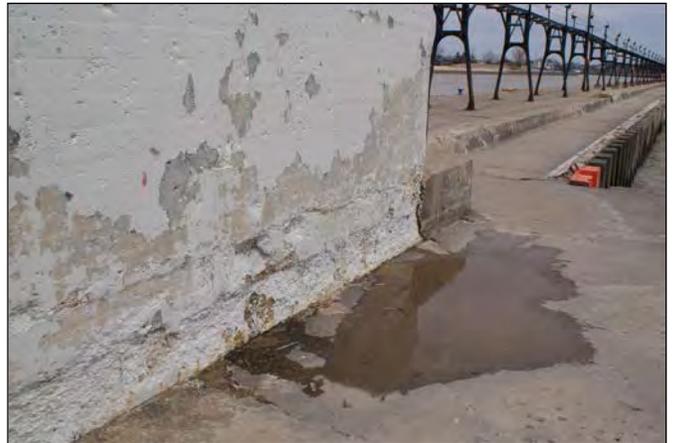
Photo III-B-21

The vertical poured concrete walls of the Entrance Light are in fair condition with some areas of spalling as seen in Photos III-B-20, III-B-21, III-B-22 and III-B-23. A cast iron clean-out, Photo III-B-24, is cast into the south wall. This clean-out served the sanitary waste line in the main level of the building.

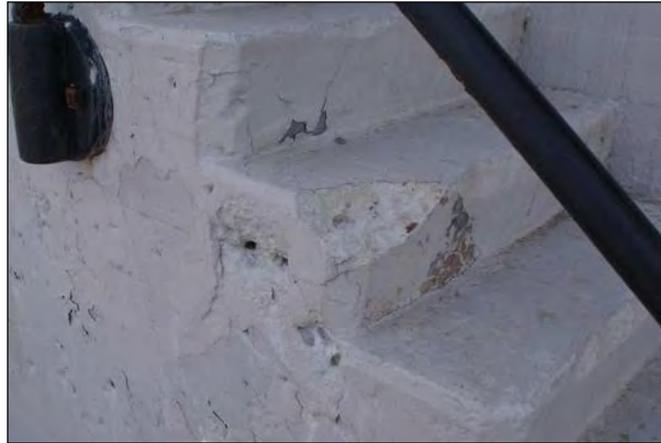
Photo III-B-26

A set of cast concrete steps is located at the southeast corner of the building and provides access to the upper level walkway as seen in Photo III-B-25. There is extensive deterioration of the concrete steps including cracking and spalling. Refer to Photos III-B-26 and III-B-27. A metal pipe handrail, which is in good condition, is anchored to the concrete wall and a 1 3/4" metal pipe handrail/guardrail is bracketed to the face of the exposed stairway wall. This handrail/guardrail is in poor condition. The base of the lowest support post, as seen in Photo III-B-28 has completely rusted and broken loose from the support bracket. Severe rusting has also occurred at other post bases and brackets.

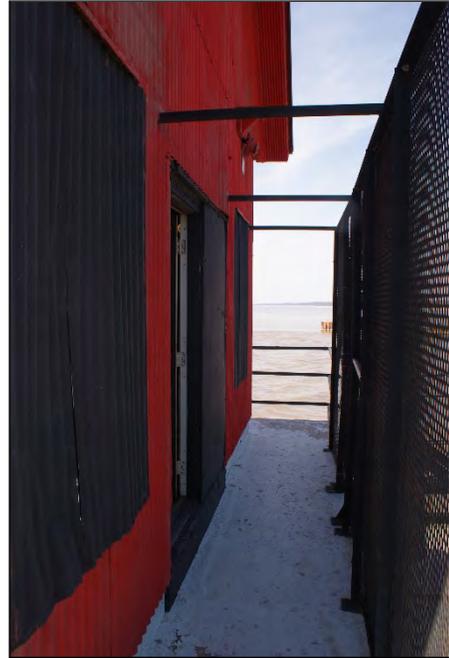
Photo III-B-33

The upper level walkway which is also the roof of the main level, is 2' – 2" wide on the north side, Photo III-B-31; and south side, Photo III-B-32 and 4' – 0" wide on the east side, Photo III-B-33. Spalled concrete edges present a safety hazard as seen in Photo III-B-34. The narrow walkway transitions to a larger deck at the west end "bow". Refer to Photos III-B-35 and III-B-36. Poured concrete walls form the guardrail along this area. The paint on these walkway surfaces, which is also the roof surface for the lower level, is in poor condition and there is some minor cracking. A metal coal room hatch, as seen in Photos III-B-37 and from the interior in Photo III-B-38, is located on this deck. The metal hatch cover and frame are rusted and the paint is in poor condition.

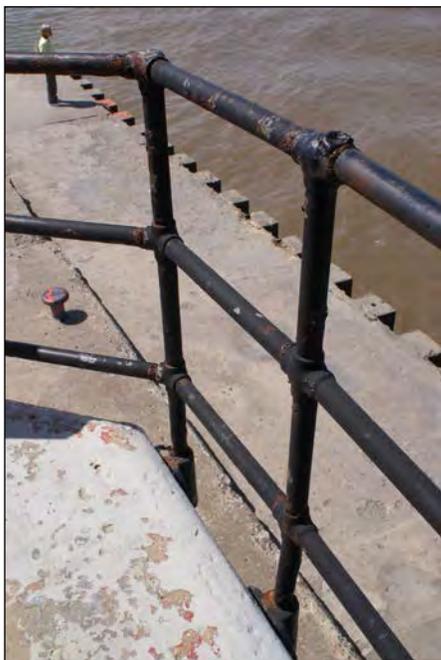
Photo III-B-39

A 3' – 6" metal pipe guardrail with three horizontal rails extends around this upper level walkway. The guardrail is constructed of 1 3/4" diameter metal pipe as seen in Photos III-B-39 and III-B-40. Similar to the railing at the stair, the guardrail posts are bracketed to the face of the concrete wall surface. Refer to Photos III-B-41 and III-B-42. Three of the guardrail pipe posts have been replaced with 2 x 2 steel angle. Many of the metal pipe guardrail components are in poor condition with members bent and rusted. The paint finish, Photo III-B-43, is in poor condition.

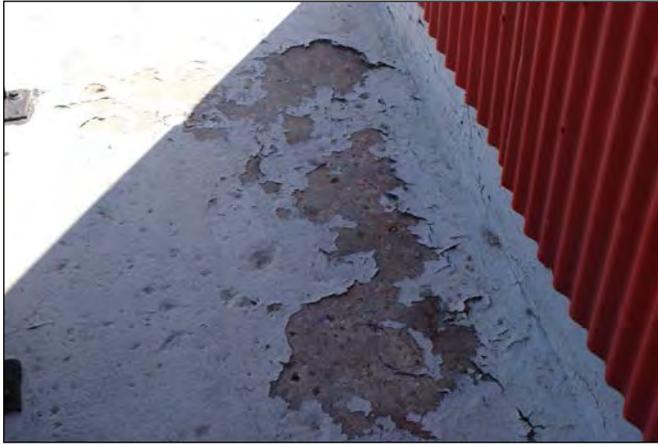
Photo III-B-44

The wood frame structure of the original Fog Signal Building is placed on an 8" high poured concrete curbs that extend around the perimeter. On three sides the corrugated metal siding overlaps this curb, Photo III-B-44; however, it transitions to a different condition on the west side as seen in Photo III-B-45. On the west side repairs or modifications have been made and the concrete curb was extended and poured over the face of the corrugated metal siding. This condition is seen in Photos III-B-46, III-B-47 and III-B-48. In addition to the voids and missing concrete, there is a gap between the concrete and the corrugated metal siding, as seen in Photo III-B- 49 that allows water to flow down the siding face and penetrate the curb.

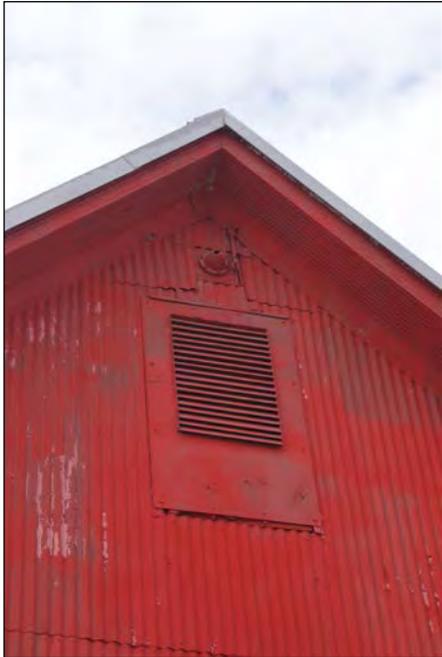
Photo III-B-53

A number of objects including a fixed ventilation louver, Photo III-B-53, an equipment support bracket and radio beacon high voltage wire terminal, Photo III-B-54, are located on the east wall of the building.

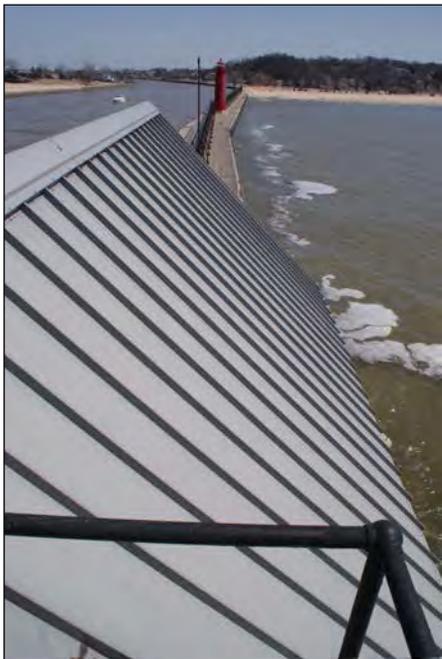
Photo III-B-55

The main roof of the Entrance Light is covered with a concealed fastener standing seam metal roof that is painted a medium grey color. The roof, seen in Photos III-B-55, III-B-56, and III-B-57, has 2" high ribs spaced 16" on center. This roof was installed in 2006 and is in very good condition. Various metal flashing and trim components, matching the same roof material color, are used throughout. Although the previous roof is reported to be a rubber membrane roof, the presence of any former roofing material was not observed.

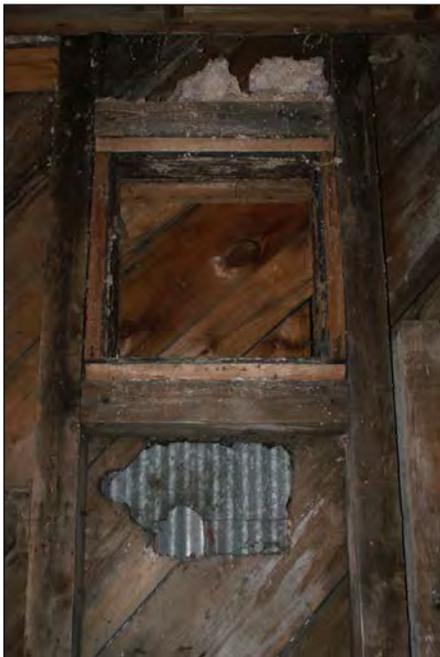
Photo III-B-58

All windows in the original wood frame structure have been removed and the openings either filled in with wood or concrete masonry units. A series of small framed openings measuring 1' – 7" x 1' – 7" on the north and south walls for original windows are visible from the building interior, Photo III-B-58. The 1922 drawings indicate these original windows to be removed, covered over, and new larger double hung windows to be installed. These larger window units are also no longer extant, with concrete masonry units infilling the 2' – 7" wide by 5' – 4" high openings as seen in Photo III-B-59. As previously discussed, black corrugated metal panels are placed on the exterior face to highlight the former window locations. On the main level of the Entrance Light there are seven large porthole style windows measuring 2' – 5" in diameter. The heavy glass, measuring $\frac{3}{4}$ " in thickness, is either missing or broken in six of the seven windows, as seen in Photos III-B-60, III-B-61 and III-B-62. All windows are covered on the exterior with steel plate that is painted black. Refer to Photo III-B-63. The frames and inward opening sash of all porthole style windows are in good condition, however, some are missing. A pivoting steel sash window located below the exterior concrete stairway was also called out on the 1922 drawings. This window has also been removed and is now filled in with concrete masonry units as seen in Photos III-B-64 and III-B-65.

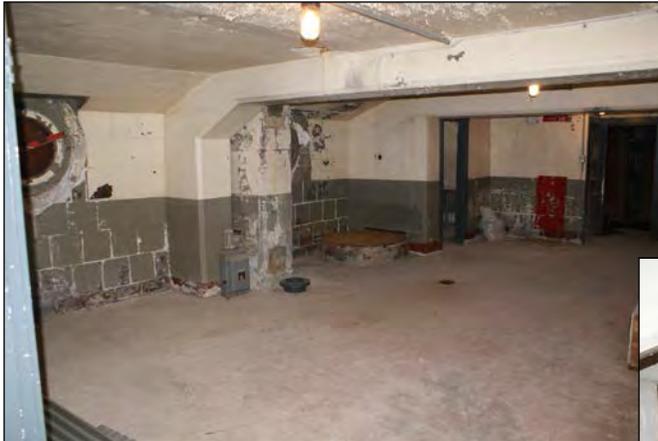
Photo III-B-77

The Equipment Room is of similar construction with a poured concrete floor and ceiling and hollow glazed tile on the walls. Views of this room are shown in Photos III-B-77 and III-B-78. Photo III-B-79 shows the substantial exposed concrete column and beam that are in this space. Two large air tanks and a 1'-4" high concrete curb containment area are located on the north wall as seen in Photo III-B-80. These tanks measure 4' in diameter by 6' high. The tanks are in good condition although most of the piping is no longer present. On the south side of the room there is a brick masonry chimney, Photo III-B-81, and an 8" high curbed structure that was the well, Photo III-B-82. There is a solid ½" thick steel plate cover on the well. This cover is rusted and the paint finish is poor. A single floor drain is present near the center of the room as seen in Photo III-B-83. The cover is missing from this drain and it is plugged with debris. It is presumed that this drain emptied directly into the lake. In the southwest corner of the Equipment Room a concrete stairway provides access to the upper level. Refer to Photos III-B-84, III-B-85 and III-B-86. A steel pipe handrail is found along the first length of the stair. The poured concrete treads and risers are in good condition however, the paint finish is in poor condition. The small space below the stairway housed a bathroom with a water closet and sink. The plumbing fixtures are no longer present, however, some remnants of piping remain, as seen in Photo III-B-87. The wood door frame into this previous bathroom remains in place, however, the 2'-4" x 6'-7" door is missing.

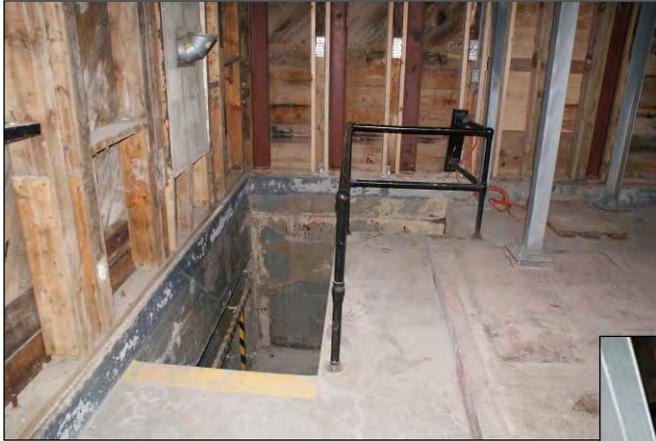
The interior concrete stairway allows access to the upper level of the Entrance Light, which is the original wood frame Fog Signal Building. Photo III-B-90 shows this stair as it transitions to the upper floor. A simple two pipe steel guardrail system, as seen in Photo III-B-91 protects the stair opening. There is no handrail on the upper run of the stair. This room is one large space with no interior finish material on the walls or ceilings; studs and ceiling joists are exposed as seen in Photos III-B-92. A small room measuring 8' x 13' constructed of 2" x 4" studs, wood paneling and gypsum board, is located within the large room, as seen in Photo III-B-93. Interior views of this room, Photos III-B-94 and III-B-95 show the damaged wall paneling and graffiti. A 2'-8" x 6'-8" hollow core wood door, Photo III-B-96, provides entry into this room. All elements of this room are in very poor condition.

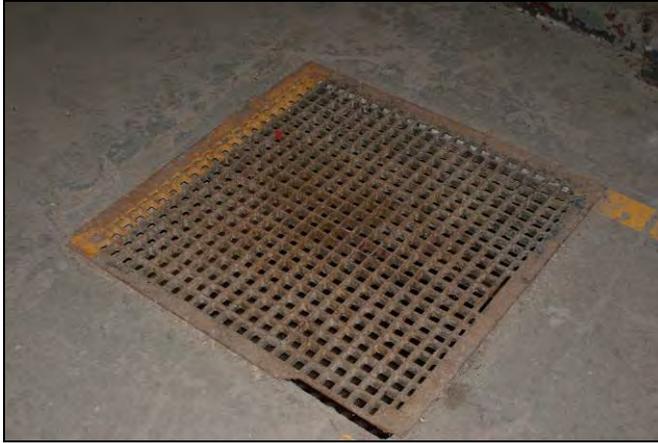
Photo III-B-97

There are four floor openings in the concrete floor slab that allow ventilation between upper and lower floors. One floor opening at the center of the room measures 2'-6" x 2'-6" and is covered with a steel grate, as seen in Photo III-B-97. Although this grate has a broken corner it is in good condition. A second floor opening that measures 2'-0" x 1'-9" is on the east side at the door opening. The grate over this opening, as seen in Photo III-B-98 is in good condition. A floor opening on the west side of the room below the lantern room is open and presents a safety hazard, as seen in Photo III-B-99. The metal grate is broken and stored against a wall. Refer to Photo III-B-100. The remaining floor opening, measuring 2'-0" x 1'-1", is along the north wall and is covered with a light gage metal grate that is bent and in bad condition, as seen in Photo III-B-101. The concrete floor / ceiling slab around this opening is badly spalled and there are remnants of a metal duct. Refer to Photo III-B-102. There are two six inch high raised concrete equipment pads in this room that present tripping hazards. See Photos III-B-103 and III-B-104. Exposed ceiling joists and the underside of partial sheathing material of the third level catwalk are visible throughout the room, as seen in Photo III-B-105.

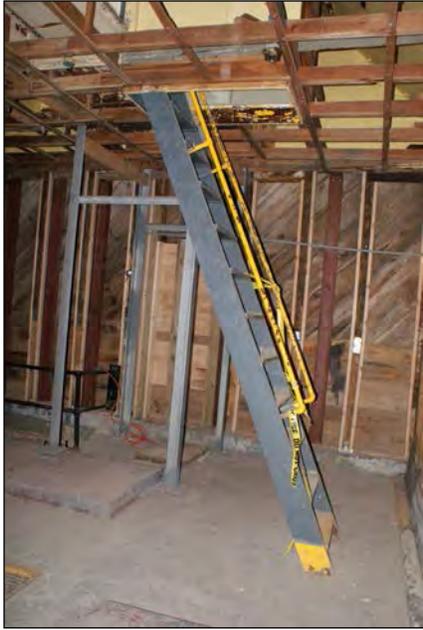
Photo III-B-106

A wood ship's ladder style stairway provides access from the upper level floor to the third level catwalk and lantern service room. This ladder, as seen in Photos III-B-106 and III-B-107, measures 2'-3" wide and has a steel pipe handrail on each side. The stair and the handrails are in good condition. Paint finish on the handrails is in poor condition.

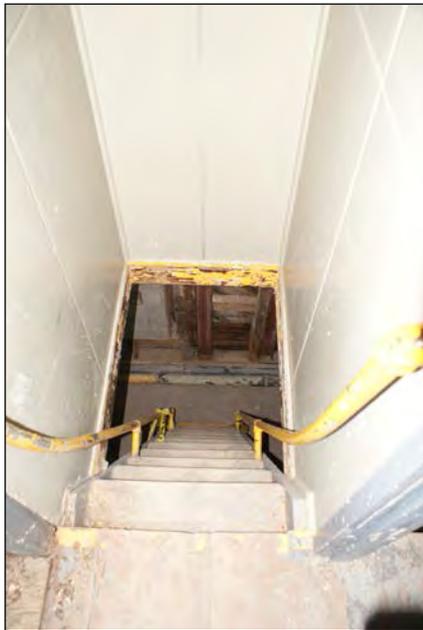
The ship's ladder stair passes through a small floor opening, Photo III-B-108 that enters a small hallway at the third level, Photo III-B-109. A 2'-7" x 6'-7" door from the hallway to the catwalk is missing. A built-in storage compartment that measures 1'-4" wide by 2'-4" high is located on the south wall, as seen in Photo III-B-110. Hinges are intact but the compartment door is missing. Finishes in this small hallway include hardboard wall paneling, a tin ceiling and wood trim. All substrate materials are in fair condition. All surfaces are painted with paint surfaces in fair to poor condition.

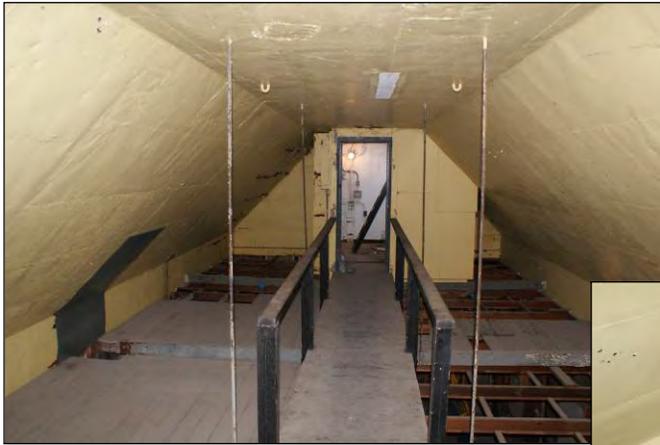
Photo III-B-111

To the east of the hallway is a 2' – 8 ½" wide wood catwalk that connects to the east end of the building where a former door was located. Views of this catwalk are seen in Photos III-B-111 and previous Photo III-B-13. The 3 ¾" x 1 ¾" painted wood handrails along the catwalk stop where plywood floor sheathing is laid on the ceiling joists, approximately 11'-8" from the east wall. The 5 1/2" wide wood sheathing is randomly place in different locations, however, much of the third level floor is open to below. Refer to Photos III-B-112 and III-B-113. Walls and ceilings of the third level are painted metal sheets as seen in previous photos. There are many rusted and deteriorated areas throughout, as seen in Photo III-B-114. At the far east end of the attic the former door opening, measuring 2'-7" x 5'-4", has been filled in with concrete masonry units. Two ventilation units are set into the masonry, as seen in Photo III-B-115. A small attic access hatch, measuring 1'-6" x 1'-3", is also located at the east end of the room. Refer to Photo III-B-116. There is also a floor and floor framing opening at the former chimney location. The wall and sloped ceiling area has been patched with metal sheets at this area, as seen in Photo III-B-117. This photo also shows the floor opening at the former chimney location. Two small lifting rings are set in the attic ceiling, as seen in Photo III-B-118.

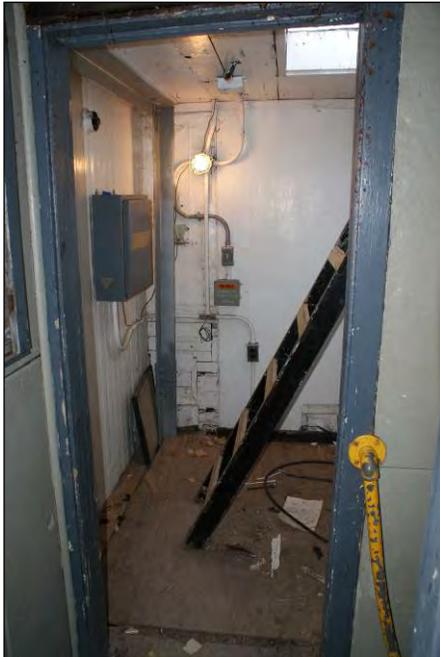
To the west of the small hallway is the lantern service and fog horn room that measures 6'-0" x 5'-3". Based on historic photographs, the fog horn would have been located directly outside of this room and piping to the fog horn would have been inside the room. Photo III-B-119 shows a view looking into this room through the hallway door. This door frame measures 2'-6" x 6'-7" and the door is missing. A variety of electronic equipment is located in this room. Interior finishes include a plywood floor, 3 ½" wide vertical wood paneling and random width wood paneling on the ceiling. The wood substrate is in good condition, however paint finishes on the walls and ceiling are in poor condition. A small ladder leads to a 1'-2" x 2'-5" floor access hatch into the Lantern, as seen in Photo III-B-120. The ladder is in good condition but it is not properly secured. There is no floor hatch cover or lid and the floor opening presents a safety hazard for anyone in the lantern.

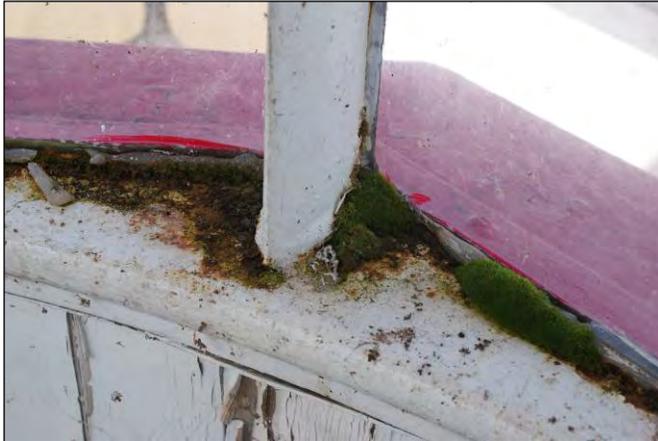
Photo III-B-127

Of the eight glazed openings in the Lantern three panels are glazed with Lexan material and two of the remaining five glass panels are broken. The glazed openings measure 2'-4 1/2" wide x 3'-0 1/2" high. The exposed metal sill and vertical mullions of the lantern are in good condition, however, the paint is in poor condition. There is considerable moss growth along the metal sill, as seen in Photo III-B-127. The lantern ceiling is exposed light gage metal with a paint finish. All metalwork is in sound condition, however, the paint finish on all surfaces is in poor condition. Refer to Photos III-B-128, III-B-129 and III-B-130.

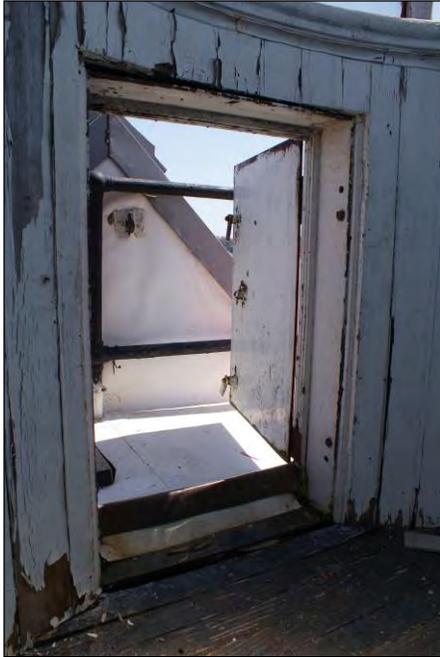
Photo III-B-131

The exterior of the lantern and the lantern deck is accessed through a 1'-8" wide x 2'-5" high access door on the east side of the lantern. Refer to Photo III-B-131. The door is a 1/4" thick metal door as seen in Photo III-B-132. The door is in good condition, however, the metal flashing and roof membrane flashing at the door sill is in poor condition as seen in Photos III-B-133 and III-B-134. The wood floor and wood trim at the base is also in poor condition around the door opening.

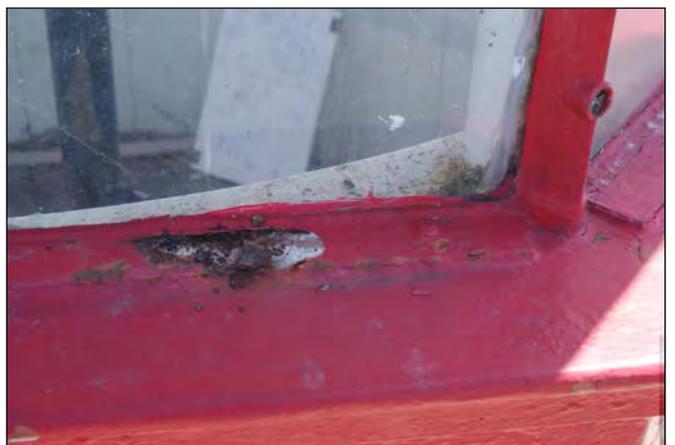
Photo III-B-138

The exterior of the lantern is shown in Photos III-B-135 and III-B-136. Exterior walls of the lantern are flush metal with a paint finish. Vents are simple capped openings, as seen in Photo III-B-137. Minor areas of damage including rust are found in various locations, as seen in Photos III-B-138, III-B-139 and III-B-140. The lantern roof is flat metal panels terminating at a simple fascia without gutters. All exterior metal on the lantern is in good condition. The paint finish is in average condition. At the peak of the lantern is a ventilator that was apparently installed as part of the 1922 renovation. It is identified as a “new ‘Kernchen’ ventilator” on these drawings and is shown in Photo III-B-141.

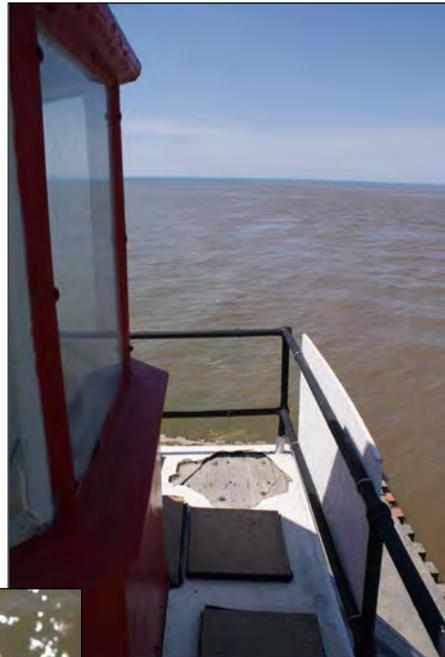
Photo III-B-142

The lantern deck is 11'-4" square with a metal pipe guardrail all around. The metal pipe guardrails and posts are 1 5/8" in diameter and have two horizontal members. The top rail is 2'-9" above the deck surface, as seen in Photo III-B-142. One original section of the top rail on the west side is missing and has been replaced with a metal pipe with a smaller outside diameter. Refer to Photo III-B-143. The metal railing is used to support navigation signage and brackets for various aids, as seen in Photos III-B-144 and III-B-145. The metal pipe rail system is in sound condition, however, the paint finish is in poor condition. The deck surface is covered with

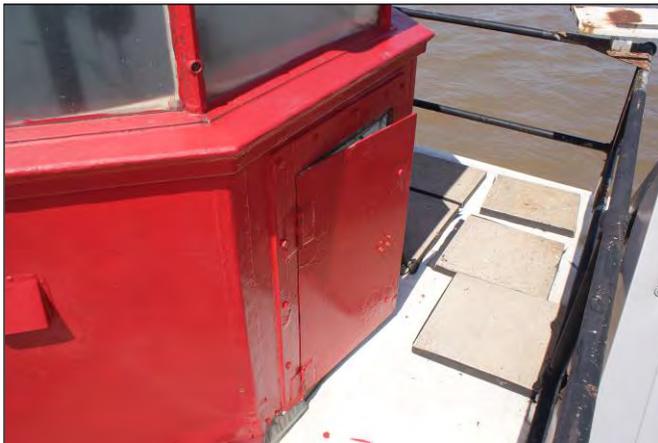
Photo III-B-146

a single ply membrane roof. Precast concrete walkway pads are placed on the roof for ballast as well as to provide a walking surface, as seen in Photos III-B-146 and III-B-147. This membrane is missing a very large section at the northwest corner of the deck, exposing the wood deck structure. Refer to Photos III-B-148 and III-B-149. This serious condition is allowing water to penetrate into the interior of the building. The roof membrane flashing wraps the guardrail posts, Photo III-B-150 and the gable end of the main building roof, Photo III-B-151. Other navigation aids, such as the fog signal device shown in Photo III-B-152, are also located on the lantern deck surface.

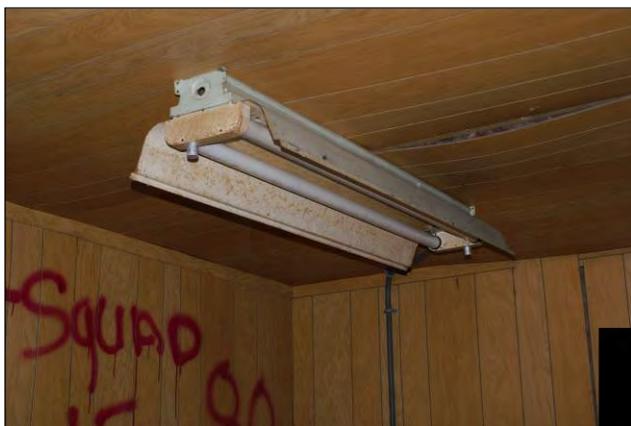
Photo III-B-158

A small number of lights and switches, most of which are operational, are located throughout the building. A non-operational fluorescent fixture, Photo III-B-158, is located in the upper level equipment room. Wall mounted fixtures, Photo III-B-159, are located on the upper floor level and similar fixtures are ceiling mounted in the various rooms on the main floor level, Photo III-B-160. Light fixtures on the upper and lower levels are controlled by a timer switch located near the entry door. A single light fixture, Photo III-B-161, and duplex receptacle, Photo III-B-162, are located in the lantern service room. All conduit is exposed.

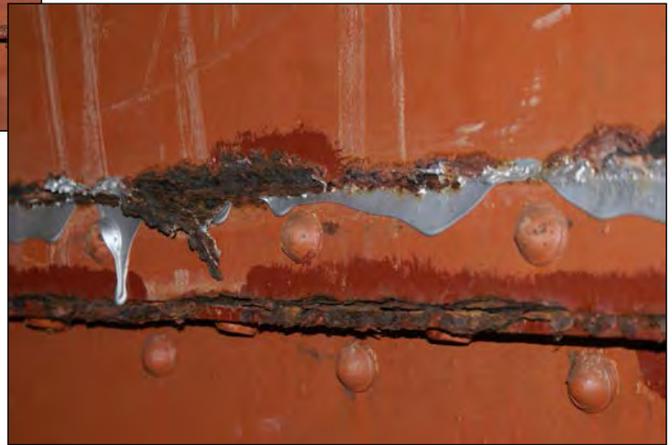
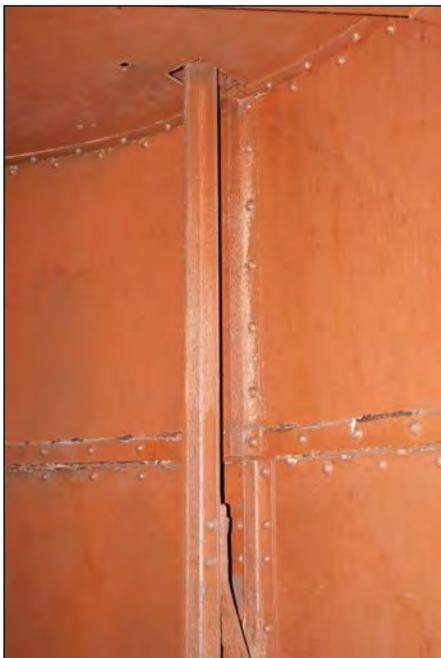
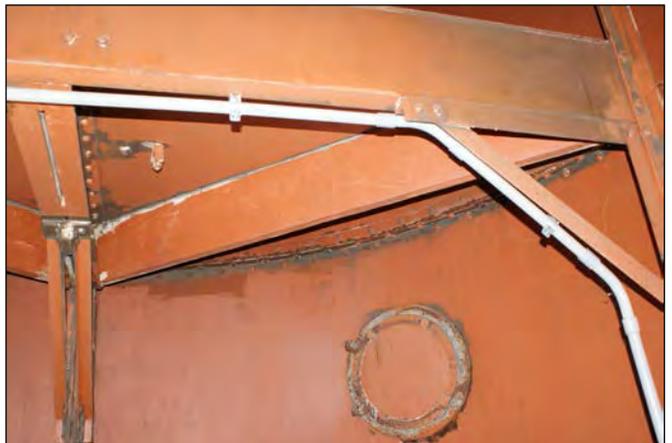
Interior views of these horizontal joints are shown in Photos III-C-3 and III-C-4 which show rust sealant material, and coatings of rust inhibitive primer. Internally there are a number of struts, bracing and other metal framework that reinforce the structure and provide framing for the floors. Photos III-C-5 and III-C-6 show some of the internal framework, which is in relatively good condition.

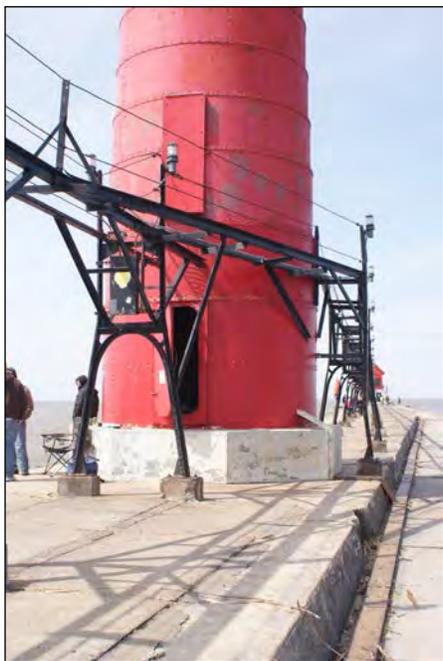
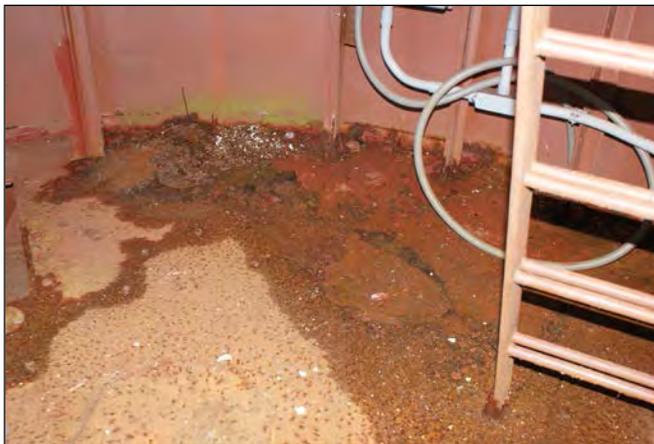
The metal tower is placed on an eight sided solid concrete base that extends 2'-8" above the pier deck surface, as seen in Photo III-C-7. The overall depth of the concrete base is not known but it is presumed to tie into the superstructure of the pier. The concrete base provides the floor structure at the main level of the tower. Refer to Photo III-C-8. As with the horizontal joints in the steel structure, the outer ledge of the concrete base allows water to flow into the interior.

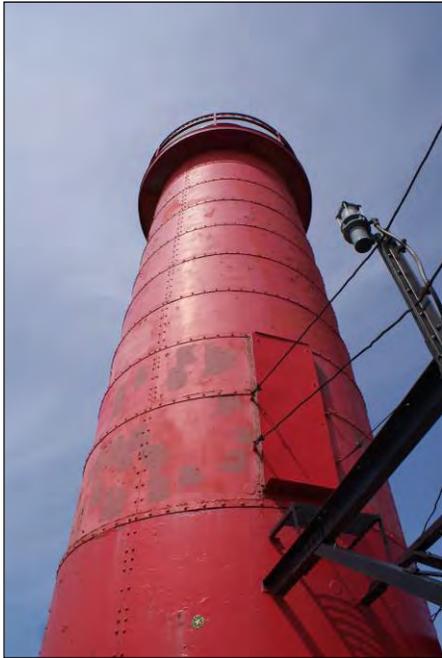
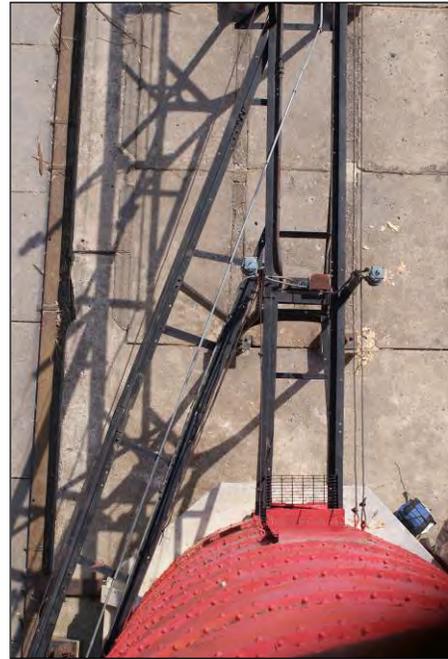
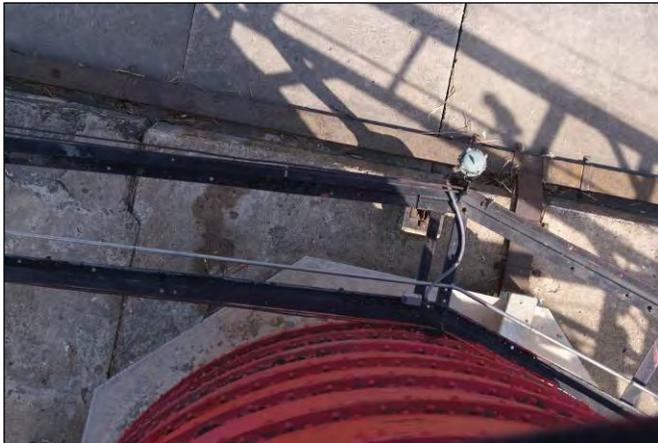
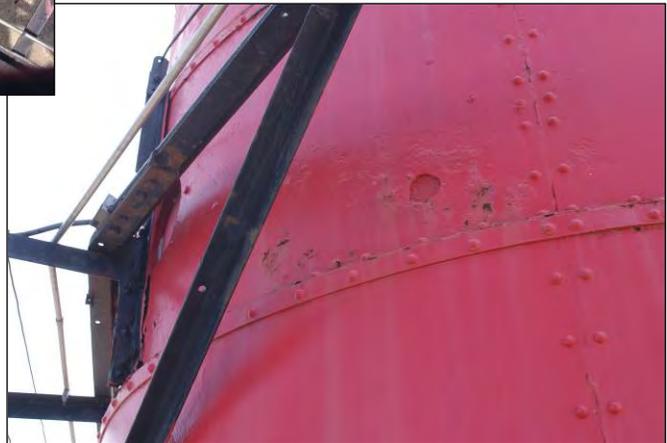
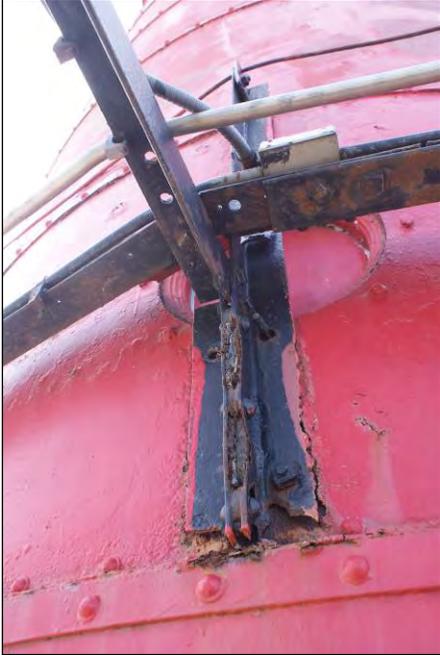
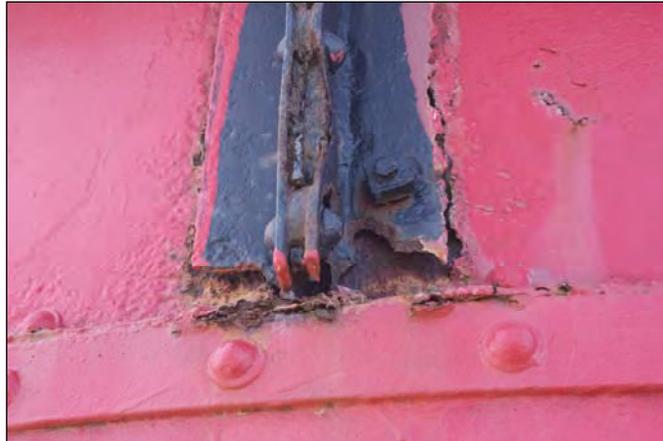
The exterior of the Inner Light is a simple metal structure with exposed metal plate, angles and rivets. All metal surfaces are painted and the paint finish is in poor condition. Refer to Photo III-C-9. Many metal surfaces have extensive rust and scale. The elevated catwalk structure is framed into the east side of the tower and then makes a dog-leg around the tower as it continues to the west. Views of the catwalk framing from the top of the tower are shown in Photos III-C-10 and III-C-11. Angles and brackets are welded to the exterior face of the tower, as seen in Photos III-C-12 and III-C-13. Extensive rusting has occurred around some brackets and the paint finish is in poor condition as seen in Photo III-C-14. The concrete base, which is in good condition, has a paint surface that is in poor condition.

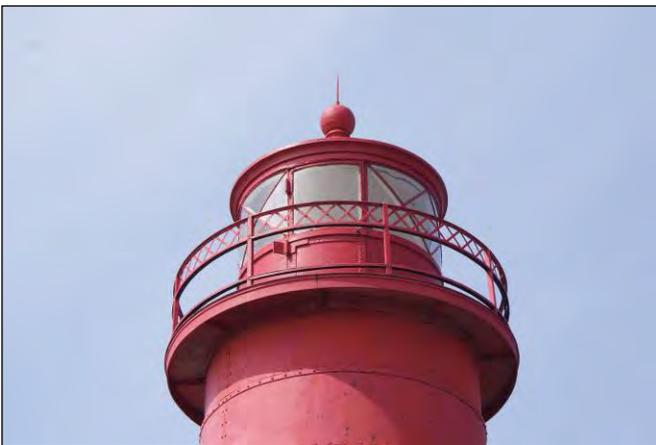
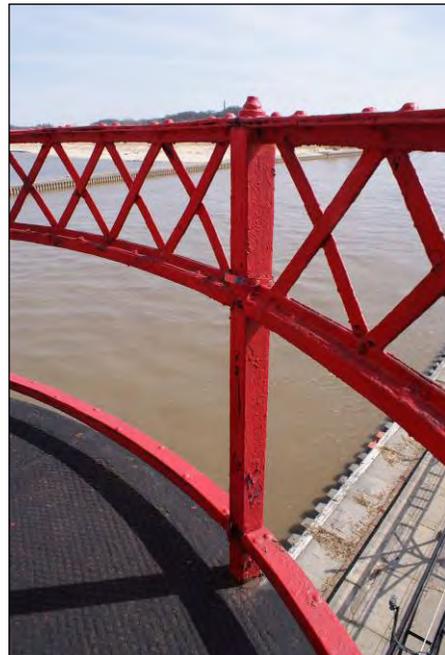
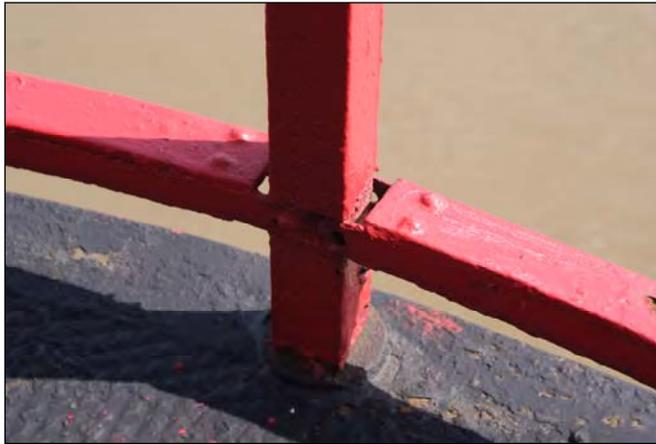
The lantern and lantern deck are placed on top of the cylindrical structure approximately 41'-8" above the main pier deck surface. The cylindrical lantern, Photo III-C-15 is 7'-8" in diameter and the circular lantern deck is approximately 13'-0" in diameter. The lantern deck is surrounded by a 3'-0 1/2" high decorative metal guardrail with a lattice pattern constructed of 1" x 1/8" flat bar as seen in Photos III-C-15 and III-C-16. The top rail is a 2" x 1 1/2" flat metal bar, and the bottom and intermediate rails are 2" wide "U" shape sections. All are connected to 2" x 2" square steel posts as seen in Photo III-C-17. The bottom horizontal rail is rusty and some connections at the posts are weak. All other guardrail components are in good condition except for some rusted areas. Paint finish is in poor condition on all guardrail components. The exterior lantern deck is metal plate that is in good condition. Paint finish is in poor condition.
