HISTORIC STRUCTURES REPORT
for
GRAND HAVEN SOUTH PIER
ENTRANCE AND INNER LIGHTS
Grand Haven (Ottawa County), Michigan

FINAL REPORT
September 8, 2015

Documentation of the existing conditions at the Grand Haven South Pier Entrance and Inner Lights was performed by Mr. Ken Czapski, AIA, a registered architect in Michigan, during a site visit on April 19 – 22, 2013. This section includes a general assessment of the pier, elevated catwalk and the entrance and inner light structures.

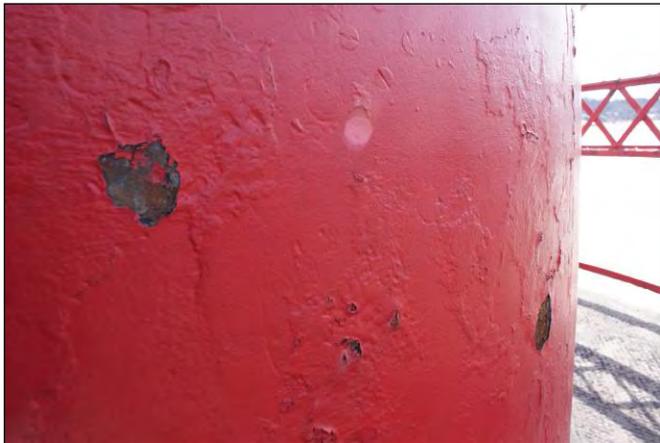
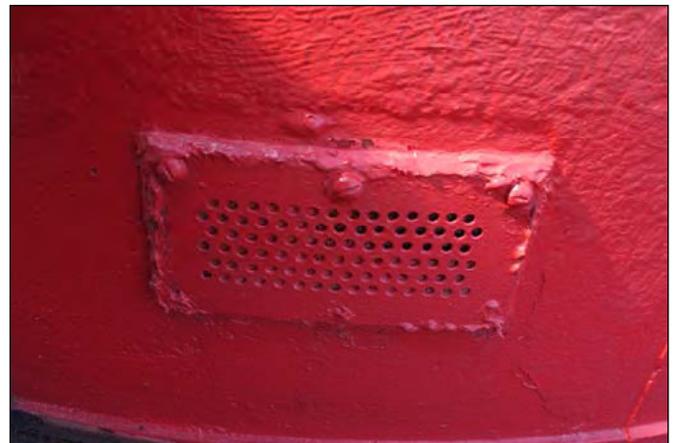
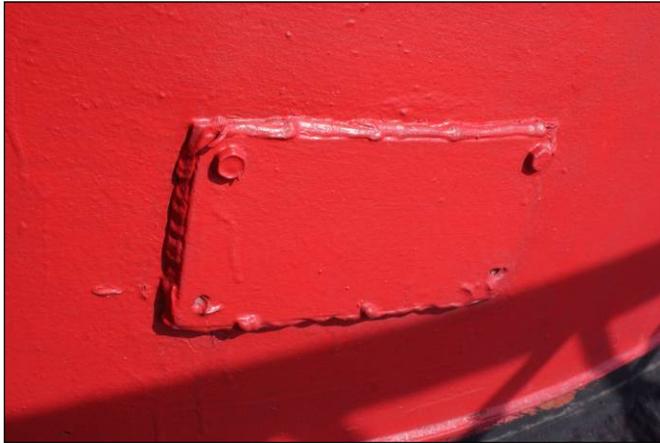
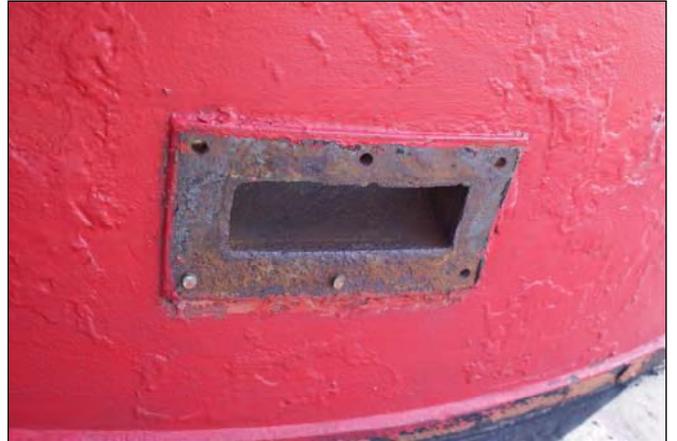
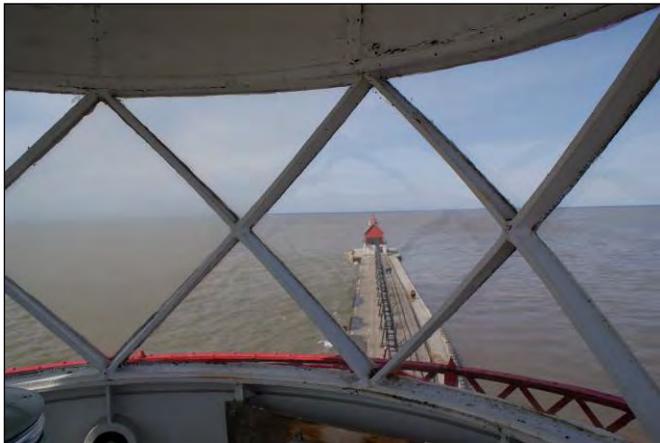
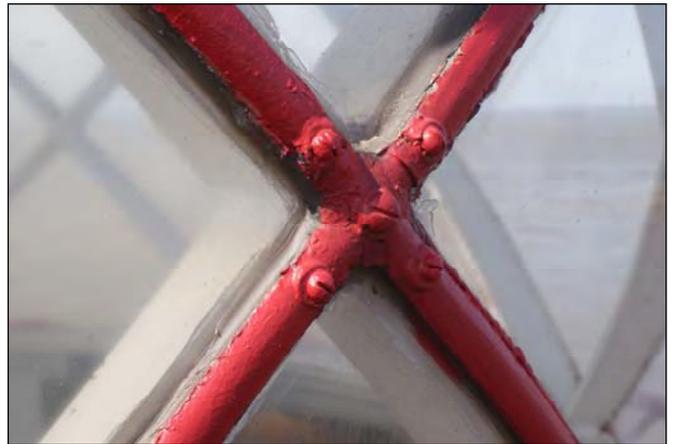
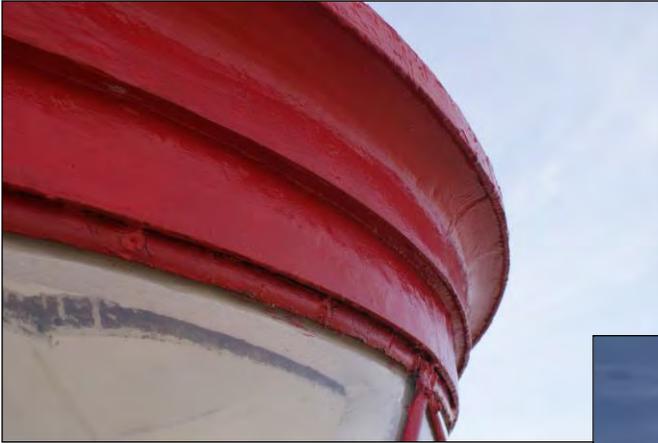
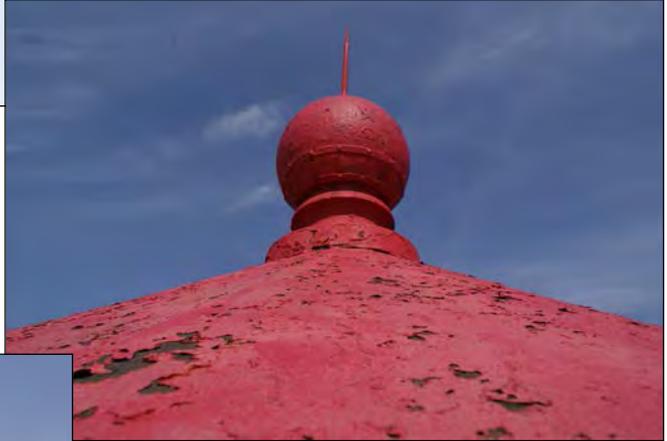
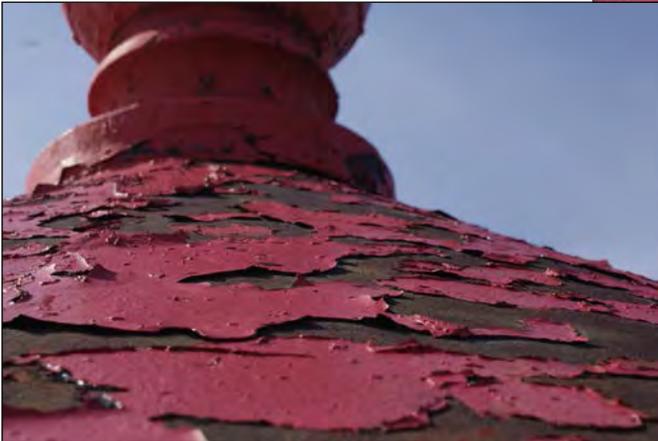
The lower walls of the lantern are curved metal with a paint finish. The exterior face of the walls are in good condition, however, the paint finish is in poor condition, as seen in Photo III-C-18. Four vent openings with perforated metal covers, Photo III-C-19, are placed around the perimeter of the lantern. One vent opening has been covered with a solid metal plate, Photo III-C-20 and at another location the cover is missing, Photo III-C-21. The lantern glazing is a unique diamond pattern, Photo III-C-22, with curved glazing mullions. Exterior glazing bars, 7/8" and 1 1/16" wide are curved and screwed into the supporting mullions, as seen in Photo III-C-23. Of the twenty openings, seven are glazed with Lexan. The remainder of the openings are glazed with curved glass which is in good condition.

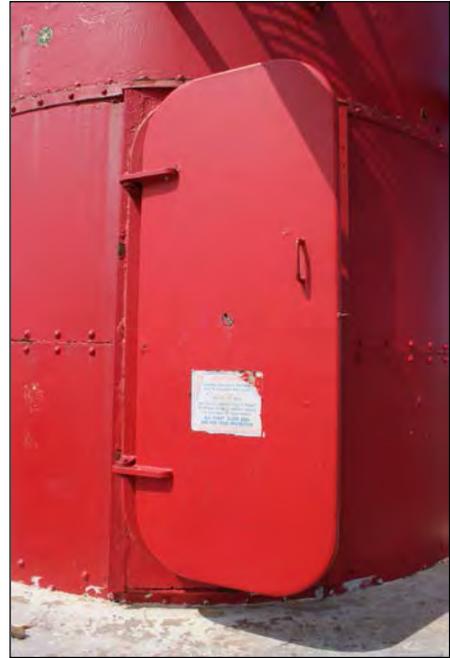
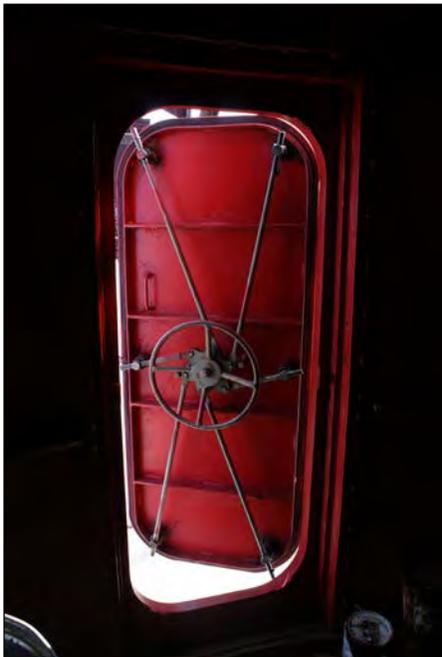
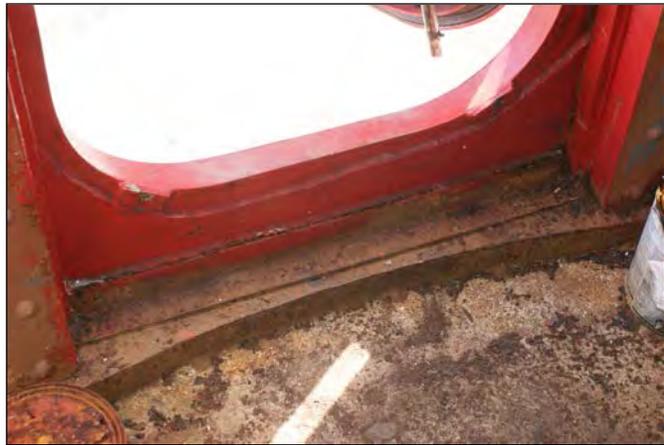
The Inner Light tower is entered through a 2'-2" x 5'-6" gasketed, water-tight steel door, as seen in Photos III-C-27, III-C-28 and III-C-29. This style of door also has a continuation of the frame at the bottom of the opening, requiring extra caution when stepping through. This condition is seen in Photo III-C-30. The door hardware consists of a pull handle and padlock hasp on the exterior and a multi-point lock mechanism on the interior. All door components are in good condition and operating order. Paint finish is in poor condition. The original 1922 drawings indicate a solid steel plate door. The water-tight door was installed in the 1990s.

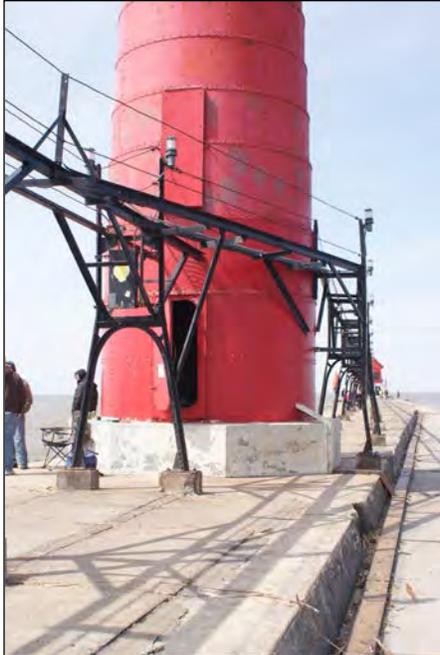
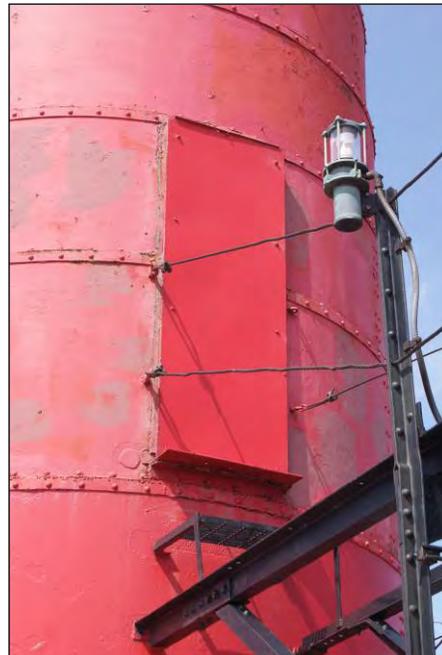
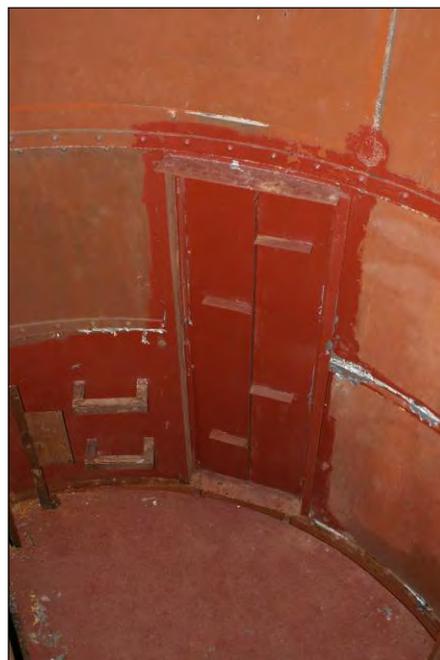
A former door opening was located at the second level where the catwalk met the light tower, as seen in Photo III-C-31 and III-C-32. This door opening, 2'-0" x 6'-5" is now covered with a metal plate that is bolted and caulked in place. An interior view of this door opening is seen in Photo III-C-33.

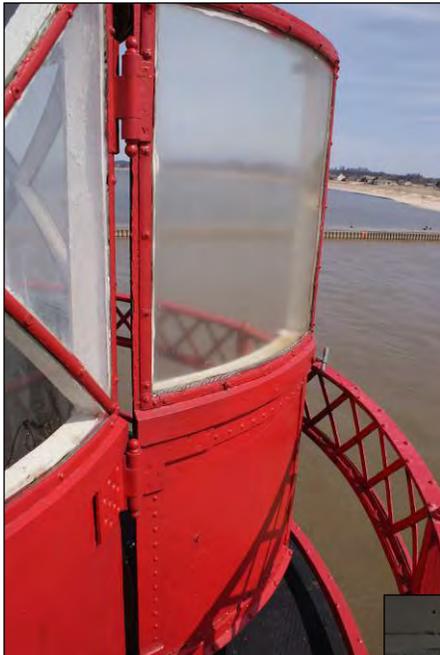
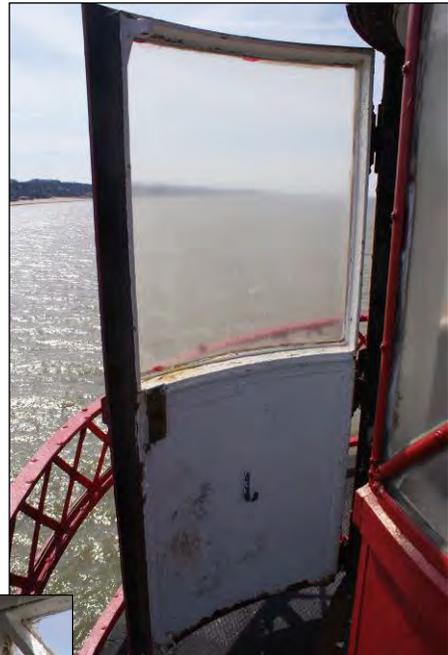
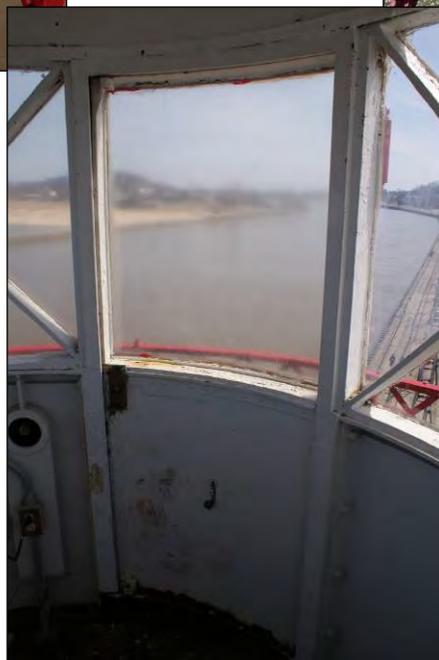
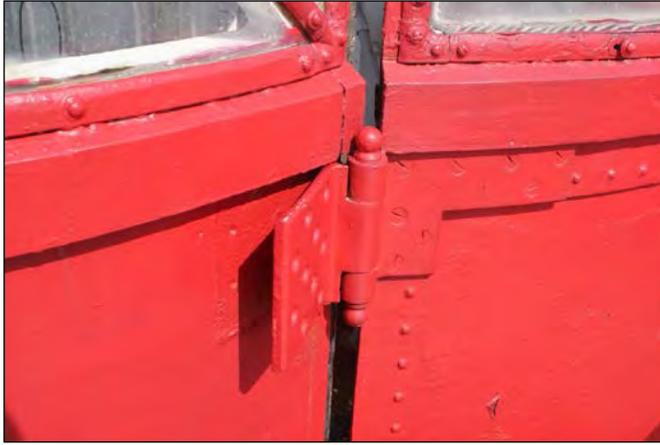
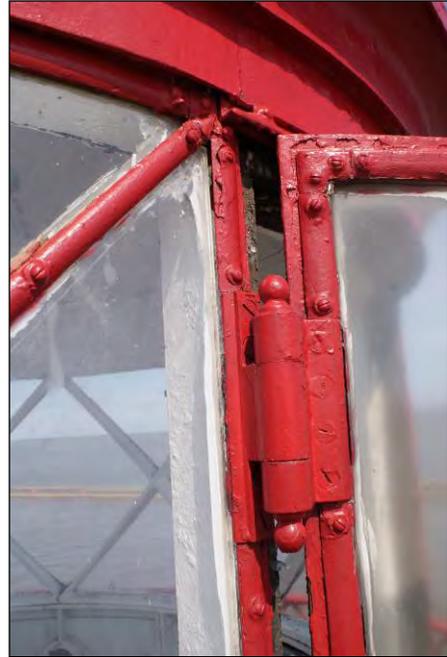
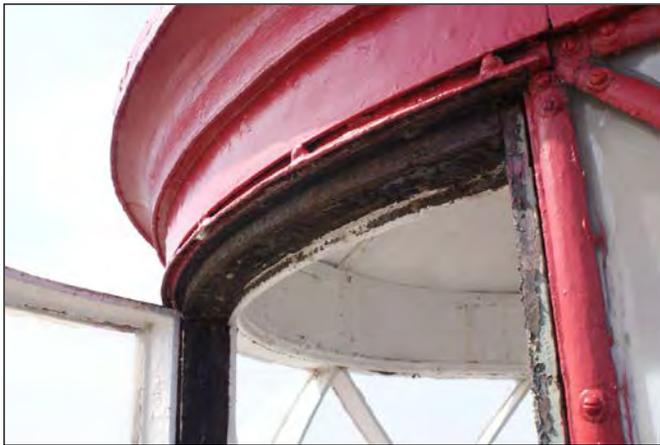
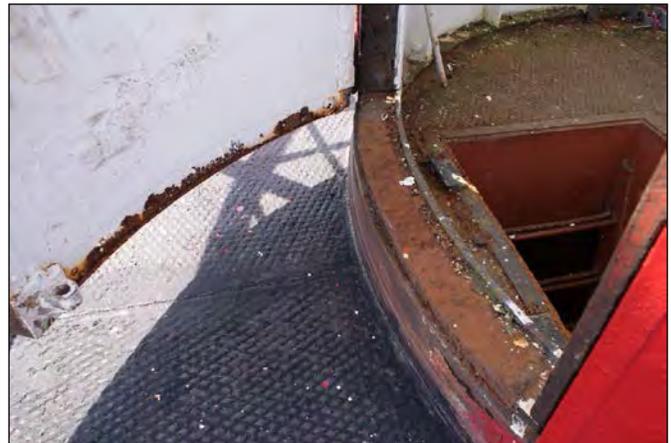
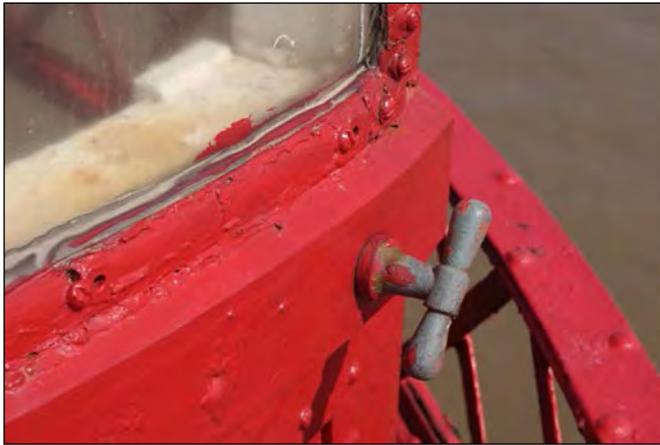
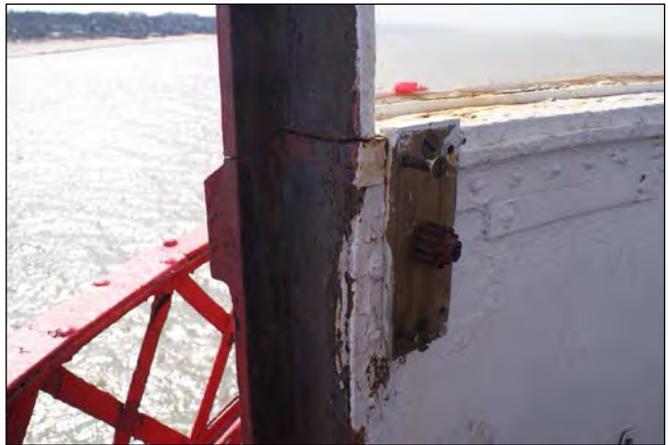
The lantern door is a large metal and glass door 2'-3 1/2" wide by 5'-10" high that is curved to match the curvature of the lantern. Refer to Photos III-C-34, III-C-35 and III-C-36. The original curved glass has been replaced with Lexan. There is a major crack in the metal door at the lower northern corner of the glazed opening directly above the latch. The crack is completely through the metal and affects the integrity of the door. Another area of concern is a loose middle hinge, as seen in Photos III-C-37. This hinge is no longer connected to the body of the lantern, with the door only supported on the lower and upper hinge, Photo III-C-38. The head and sill of the door are shown in Photos III-C-39 and III-C-40. Door frame metalwork is in good condition, however, all paint finishes are in poor condition. Door hardware consists of a small turn handle on the exterior, Photo III-C-41, and partial components of a vertical rod latch mechanism, Photo III-C-42. Remnants of the vertical rod latch device are laying in the lantern, as seen in Photo III-C-43.

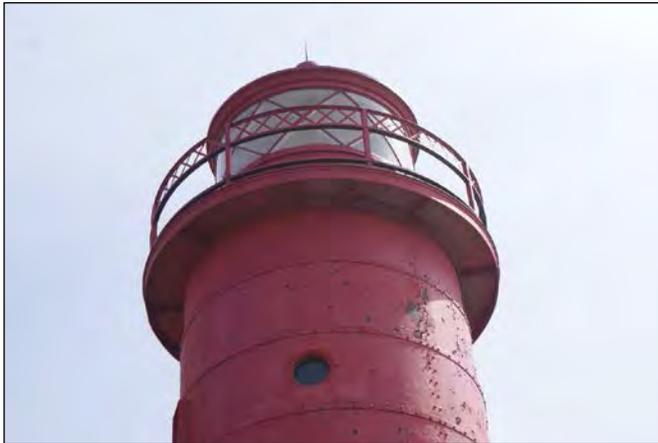
Photo III-C-44

Other than the lantern glazing, previously discussed, window openings include five small porthole style windows located at different elevations along the height of the tower. These porthole windows are seen in previous photographs and Photo III-C-44. The inward swinging sash at the two porthole windows at the first level are missing and a steel plate cover has been welded to the frame, as seen in Photo III-C-45. The operable sash and glazing are intact at the three window openings at the upper levels. Refer to Photo III-C-46. The inward swinging sash is 1'-4" in diameter with a 1'-2 1/2" diameter glass opening. Paint finish is in poor condition on all windows.

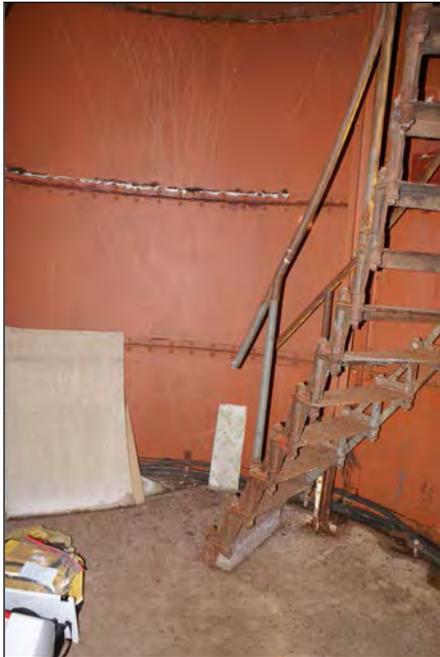
The interior of the Inner Light tower is a simple and utilitarian space consisting of open rooms and stairs that allow access to the lantern and the light. All walls are the inside face of the metal cylindrical sections that form the structure of the tower. The main floor, at 2'-8" above the pier deck surface, is an open room approximately 12'-4" in diameter with a series of electrical panels and the circular stair that provides access to the second level. A partial view of this room at the bottom of the stair is seen in Photo III-C-47 and a view looking up in Photo III-C-48. The concrete floor slab is in reasonably good condition with some minor spalling and deterioration at the entry door. There is moisture around the perimeter where the metal cylindrical walls sit upon the concrete base. Refer to Photo III-C-49. There is considerable rusting along many of the horizontal joints around the perimeter walls, as seen in Photos III-C-50 and III-C-51. All interior wall surfaces are painted with a red primer paint that is in poor condition.

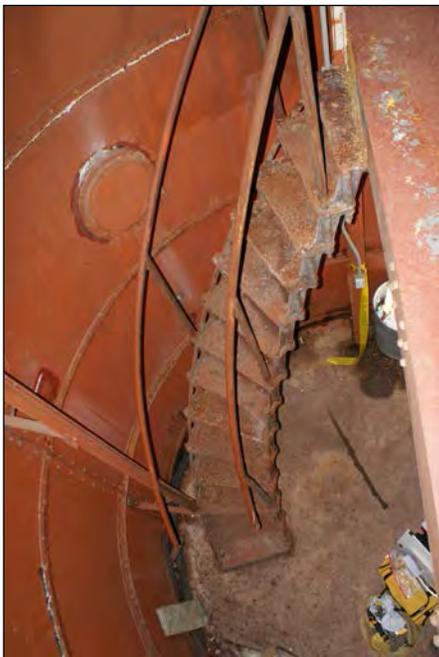
Photo III-C-52

The curved 2'-0" wide metal stair, as seen from the second level in Photo III-C-52, provides access to a partial floor that is 11'-1" above the main level. A metal pipe handrail is present on both sides of the stair. The second floor level, which functions as more of a stair landing, is only one-half of the floor structure and 11'-9" in diameter as seen in Photo III-C-53. The open side of the floor, which is constructed of 1/4" thick steel plate, is protected by a single 1 5/8" steel pipe guardrail that is 3'-2" above the floor. With no intermediate rail or toe plate, as seen in Photos III-C-54 and III-C-55, this is a rather dangerous condition for people on this level. At the base of the stair that goes up from this second level there is an unprotected floor opening along the outside wall that also presents a safety concern. This condition is shown in Photo III-C-56.

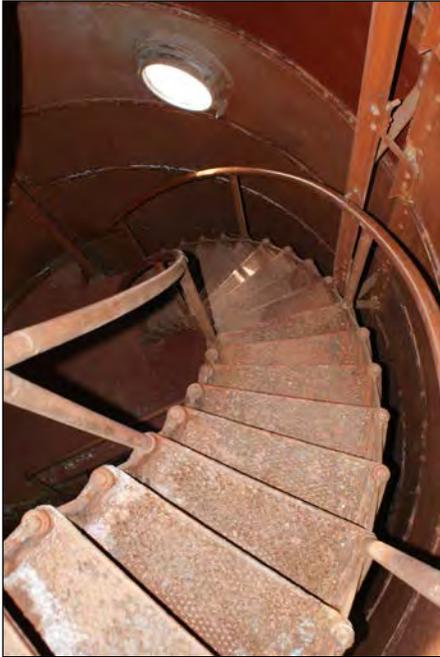
Photo III-C-57

From the second level, the curved metal stair goes up 15'-10 ³/₄" to the third level, Photo III-C-57. Photo III-C-58 shows the intricate tread and riser system typical of the circular stair in this tower. The paint finish, as seen in Photo III-C-59, is in poor condition on all stair components. A floor opening allows access from the stair to the third floor, as seen in Photos III-C-60 and III-C-61. Two hinges remain on the outside edge of this opening indicating the past presence of a hatch cover at this opening. Photo III-C-62 shows one of the hinges. A simple two pipe guardrail, constructed of 1 5/8" diameter steel pipe protects this opening, as seen in Photo III-C-63. The third floor level, which is 10'-8" in diameter, is constructed of 1/4" thick steel plate. There is severe water penetration through the tower walls that is collecting at this floor level, as seen in Photos III-C-64 and III-C-65. The steel plate floor is severely rusted and appears weakened in one area. A loose steel cover plate, Photo III-C-66, is positioned over a 12" diameter floor opening. Because this cover plate is not secured, this floor opening is a safety hazard.

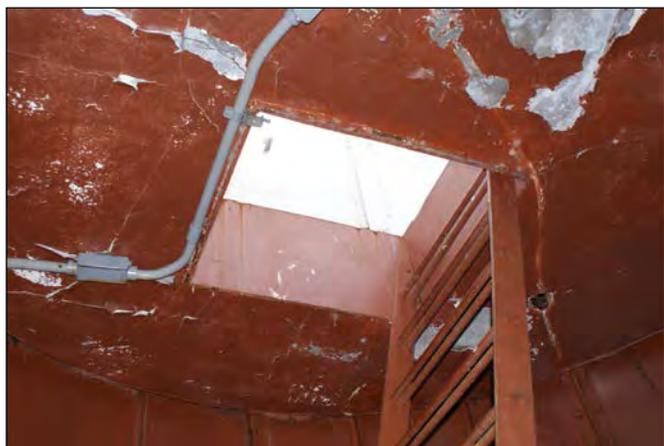
Photo III-C-68

A fixed steel ladder with double rungs provides access to the lantern. Refer to Photo III-C-67. A 1'-11" x 2'-5" floor opening in the lantern floor is seen in Photos III-C-68 and III-C-69. Two damaged hinges, Photo III-C-70, are found along the edge of the opening and the steel plate hatch cover is removed and laid against the lantern wall as seen in Photo III-C-71. The ceiling of the third level, or the underside of the lantern deck floor, is cement plaster which is in poor condition. Photo III-C-72 shows the loose and missing plaster. The paint finish is in poor condition.

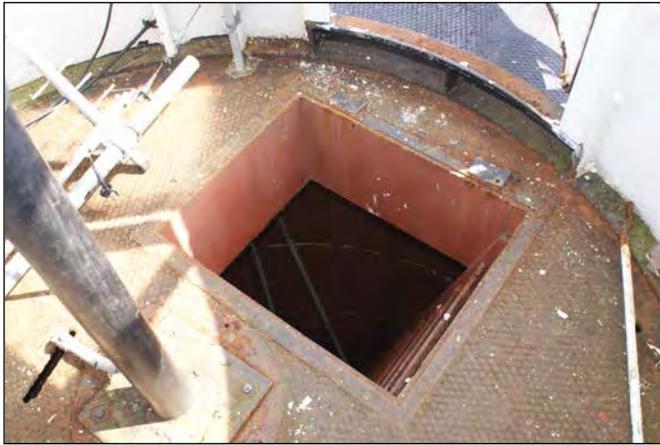
Photo III-C-73

The lantern is cylindrical with an inside diameter of 7'-7" and houses the navigational beacon. The lantern floor is metal plate. The paint finish on the floor is in poor condition as seen in Photos III-C-73 and III-C-74 with water penetration and rusting occurring at the edge of the lantern walls, Photo III-C-75. Eight sections of wall panels form the base of the lantern that is 3"-6 5/8" high, as seen in Photo III-C-76. Four vents are symmetrically placed around the lantern. All are missing the covers, as seen in Photo III-C-77. The wall panels transition to a unique diamond pattern curved glazing system, Photos III-C-78. The diagonal mullions are in good condition, however, the paint finish is in poor condition. As previously discussed there are twenty two glass panels. Fifteen are curved glass and seven panels have been replaced with Lexan material. The original glass panels are in good condition. The lantern glass transitions to a metal ceiling, as seen in Photo III-C-79. The metal ceiling panels, which are topped by a vent as seen in Photo III-C-80, are in good condition. All paint surfaces are in poor condition.

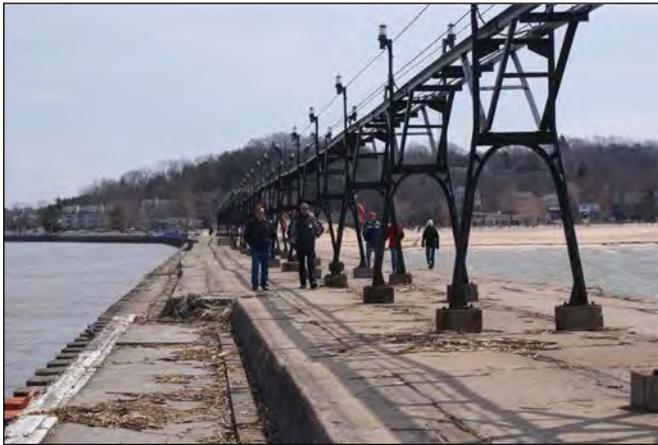
Electrical service to the Inner Light is extended along the south pier from the shore. Cables are run in a conduit constructed of 8" steel c-channel that is nestled along the lower surface of the pier deck. This c-channel is shown in Photo III-C-81 where it is positioned against the step that is formed between the upper and lower walking surfaces. The electric service extends into the Inner Light tower on the north side where the 8" steel c-channel conduit steps up the pier and tower base and enters into the bottom of the metal tower, as seen in Photo III-C-82. The steel channel is in sound condition, however, the paint finish is in poor condition; some of the anchors and straps are broken. This electrical service is under the jurisdiction of the U. S. Coast Guard. Three large electrical cables enter the metal tower, Photo III-C-83, and run unprotected along the perimeter of the main floor, Photo III-C-84, and then extend into the first electrical junction box, as seen in Photo III-C-85. Although these electrical cables are sheathed, they present a safety hazard and possible tripping hazard. A plywood panel is placed on the south wall of the main level and a series of electrical panels and shut-offs are located there that include a 600 volt Main Sub-Cable junction box, a 600 volt to 120 volt step-down panel, a 100 amp sub-panel, a 600 volt disconnect for the Entrance Light and a 600 volt disconnect for the Inner Light. The Inner Light electrical distribution panel acts as the junction box and disconnect for the Entrance Light. These panels are shown in Photo III-C-86. Two electrical panels are located on the third level of the tower, as seen in Photo III-C-87, and one is in the lantern, Photo III-C-88. All electrical panels and disconnects appear in good condition.

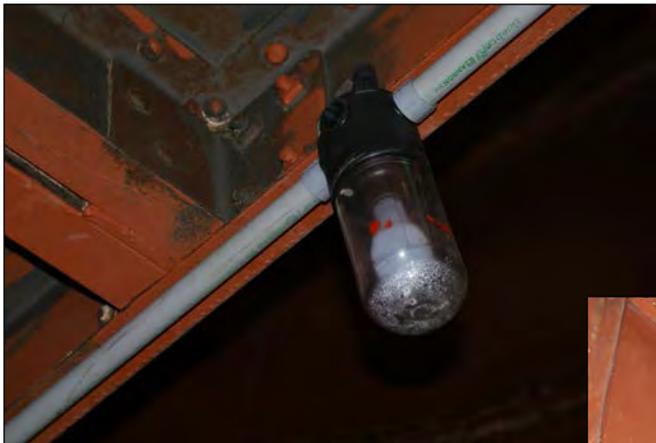
Photo III-C-89

A small number of light fixtures are placed throughout the interior of the light tower and lantern, as seen in Photos III-C- 89, III-C-90 and III-C-91. A timer switch, Photo III-C-92, is located on the main level at the entry door and controls all lights. A few duplex electrical receptacles are located throughout. Wiring to all lights and receptacles is placed in PVC conduit.

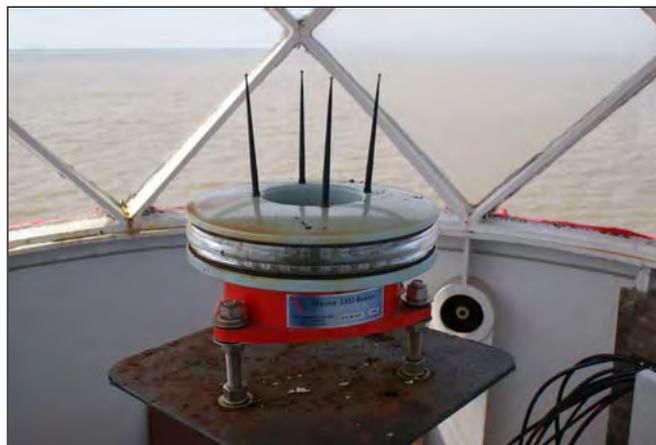
Photo III-C-93

The navigation light located in the lantern is a Marine LED Beacon manufactured by Vega Industries, Ltd., Model Number VLB – 38, Serial Number 38-0261-1999. This light, which is maintained by the U. S. Coast Guard, is shown in Photo III-C-93.
